Year 4 Annual Report
Massachusetts Small MS4 General Permit
Reporting Period: July 1, 2021-June 30, 2022

City of Fitchburg, Massachusetts Illicit Discharge Detection & Elimination Program Catchment Area C220

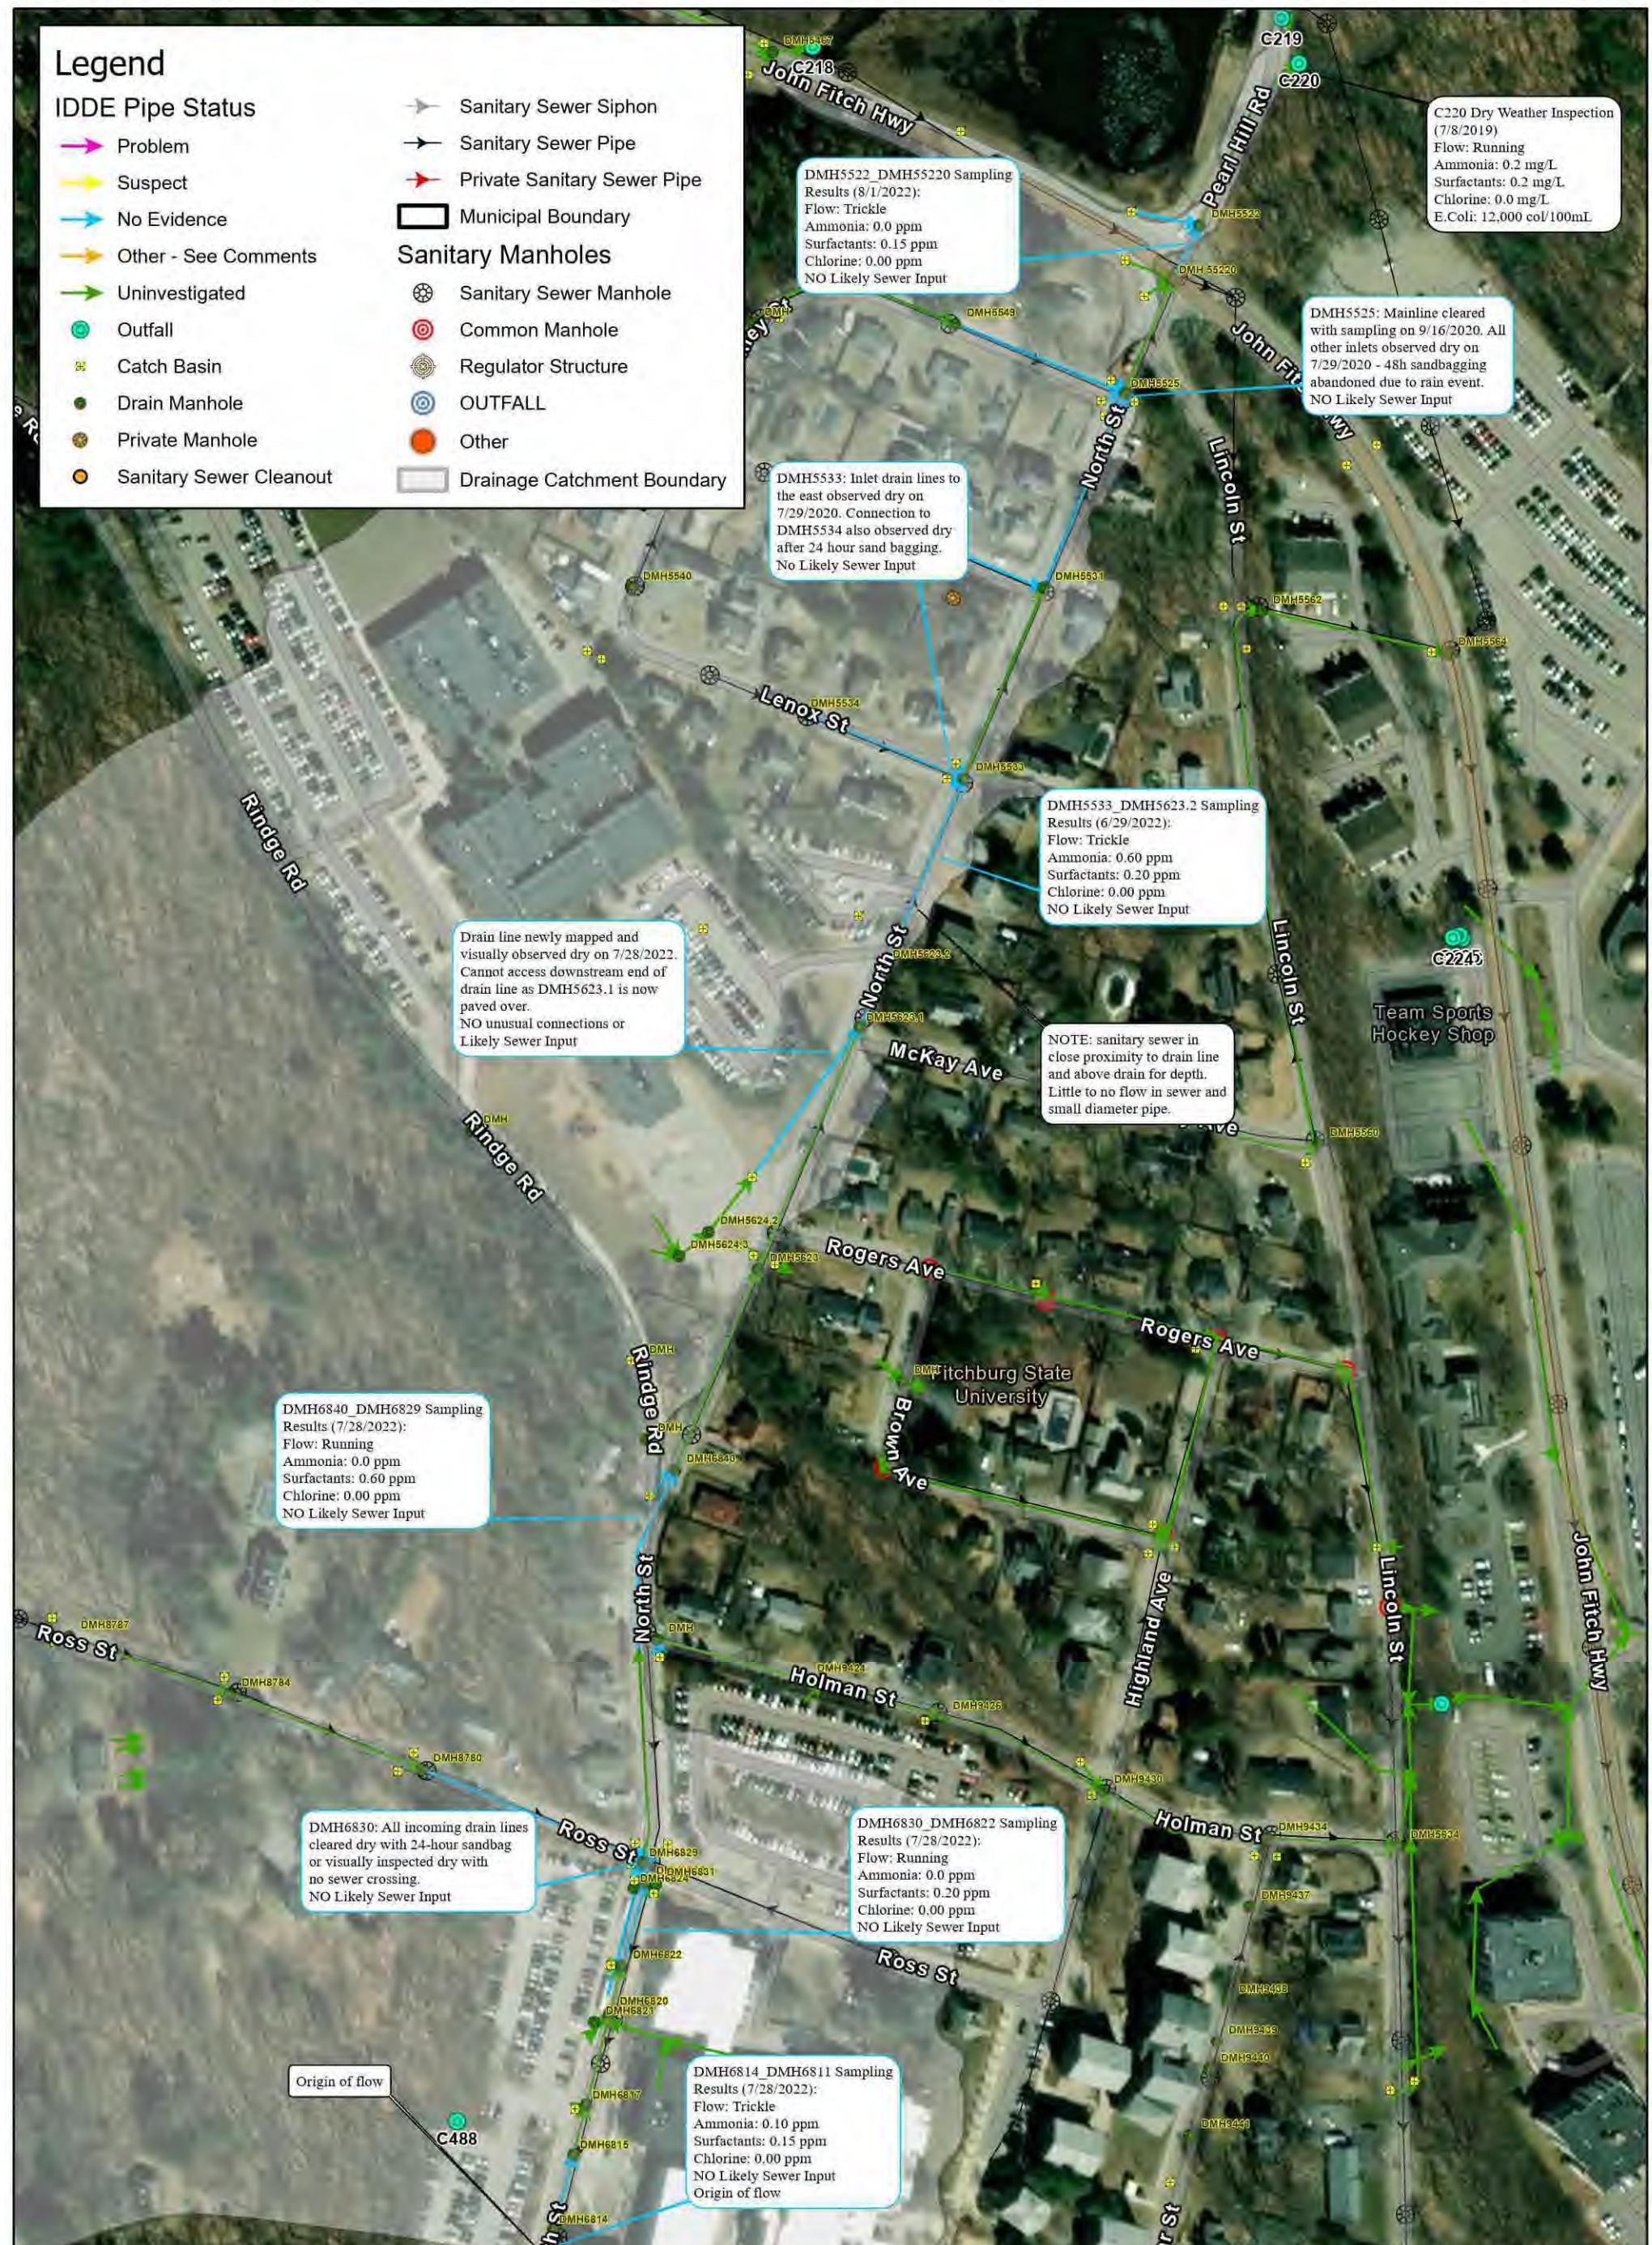
C220	DMH5533	NORTH STREET	DMH5534	DMH5534-DMH5533	8/13/20	12	VCP	Dry	48h Sandbag - Dry									No Evidence	24 hour sandbag	
C220	DMH5533	NORTH STREET	CB5533.1	CB5533.1-DMH5533	7/29/20	6	PVC	Dry	General Observation									No Evidence	Observed Dry, pipe does not cross sanitary system	
C220	DMH6829	NORTH STREET	DMH683	DMH683-DMH6829	7/29/20	16	HDPE	Flow - Running	Sampled Flow	0.05	0.15	0.00	81.6	6.76	0.10	298.0		No Evidence		
C220	DMH6829	NORTH STREET	DMH684	DMH6829-DMH684	7/29/20	18	RCP	Flow - Running	General Observation									Other - See Comments	Outgoing pipe	
C220	DMH6829	NORTH STREET	CB6828	CB6828-DMH6829	7/29/20	6	PVC	Dry	General Observation									No Evidence	Observed dry, could not get sandbag in pipe	
C220	DMH6829	NORTH STREET	CB6825	CB6825-DMH6829	7/29/20	6	VCP	Dry	General Observation									No Evidence	Observed Dry, pipe does not cross sanitary system	
C220	DMH6829	NORTH STREET	CB6826	CB6826-DMH6829	7/29/20	6	VCP	Dry	General Observation									No Evidence	Observed Dry, pipe does not cross sanitary system

C220	DMH6829	NORTH STREET	DMH6829.1	DMH6829.1-DMH6829	8/13/20	12	VCP	Dry	48h Sandbag - Dry									No Evidence	24 hour sandbag	
C220	DMH6829	NORTH STREET	CB6827	CB6827-DMH6829	7/29/20	6	VCP	Dry	General Observation									No Evidence	Observed Dry, pipe does not cross sanitary system	
C220	DMH5531	North@Garfield	DMH5525	DMH5531-DMH5525	9/16/20	24	VCP	Dry	General Observation									No Evidence		
C220	DMH5531	NORTH@GARFIELD	UNK	UNK-DMH5531	9/16/20	6	VCP	Dry	General Observation									No Evidence		
C220	DMH5531	North@Garfield	DMH5533	DMH5533-DMH5533	9/16/20	24	VCP	Dry	General Observation									No Evidence		
C220	DMH5531	North@Garfield	UNK	UNK-DMH5531	9/16/20	6	VCP	Dry	General Observation									No Evidence		
C220	DMH5531	North@Garfield	UNK	UNK-DMH5531	9/16/20	12	VCP	Dry	24 Hour Sandbag									No Evidence		
C220	DMH5531	North@Garfield	UNK	UNK-DMH5531	9/16/20	6	VCP	Dry	General Observation									No Evidence

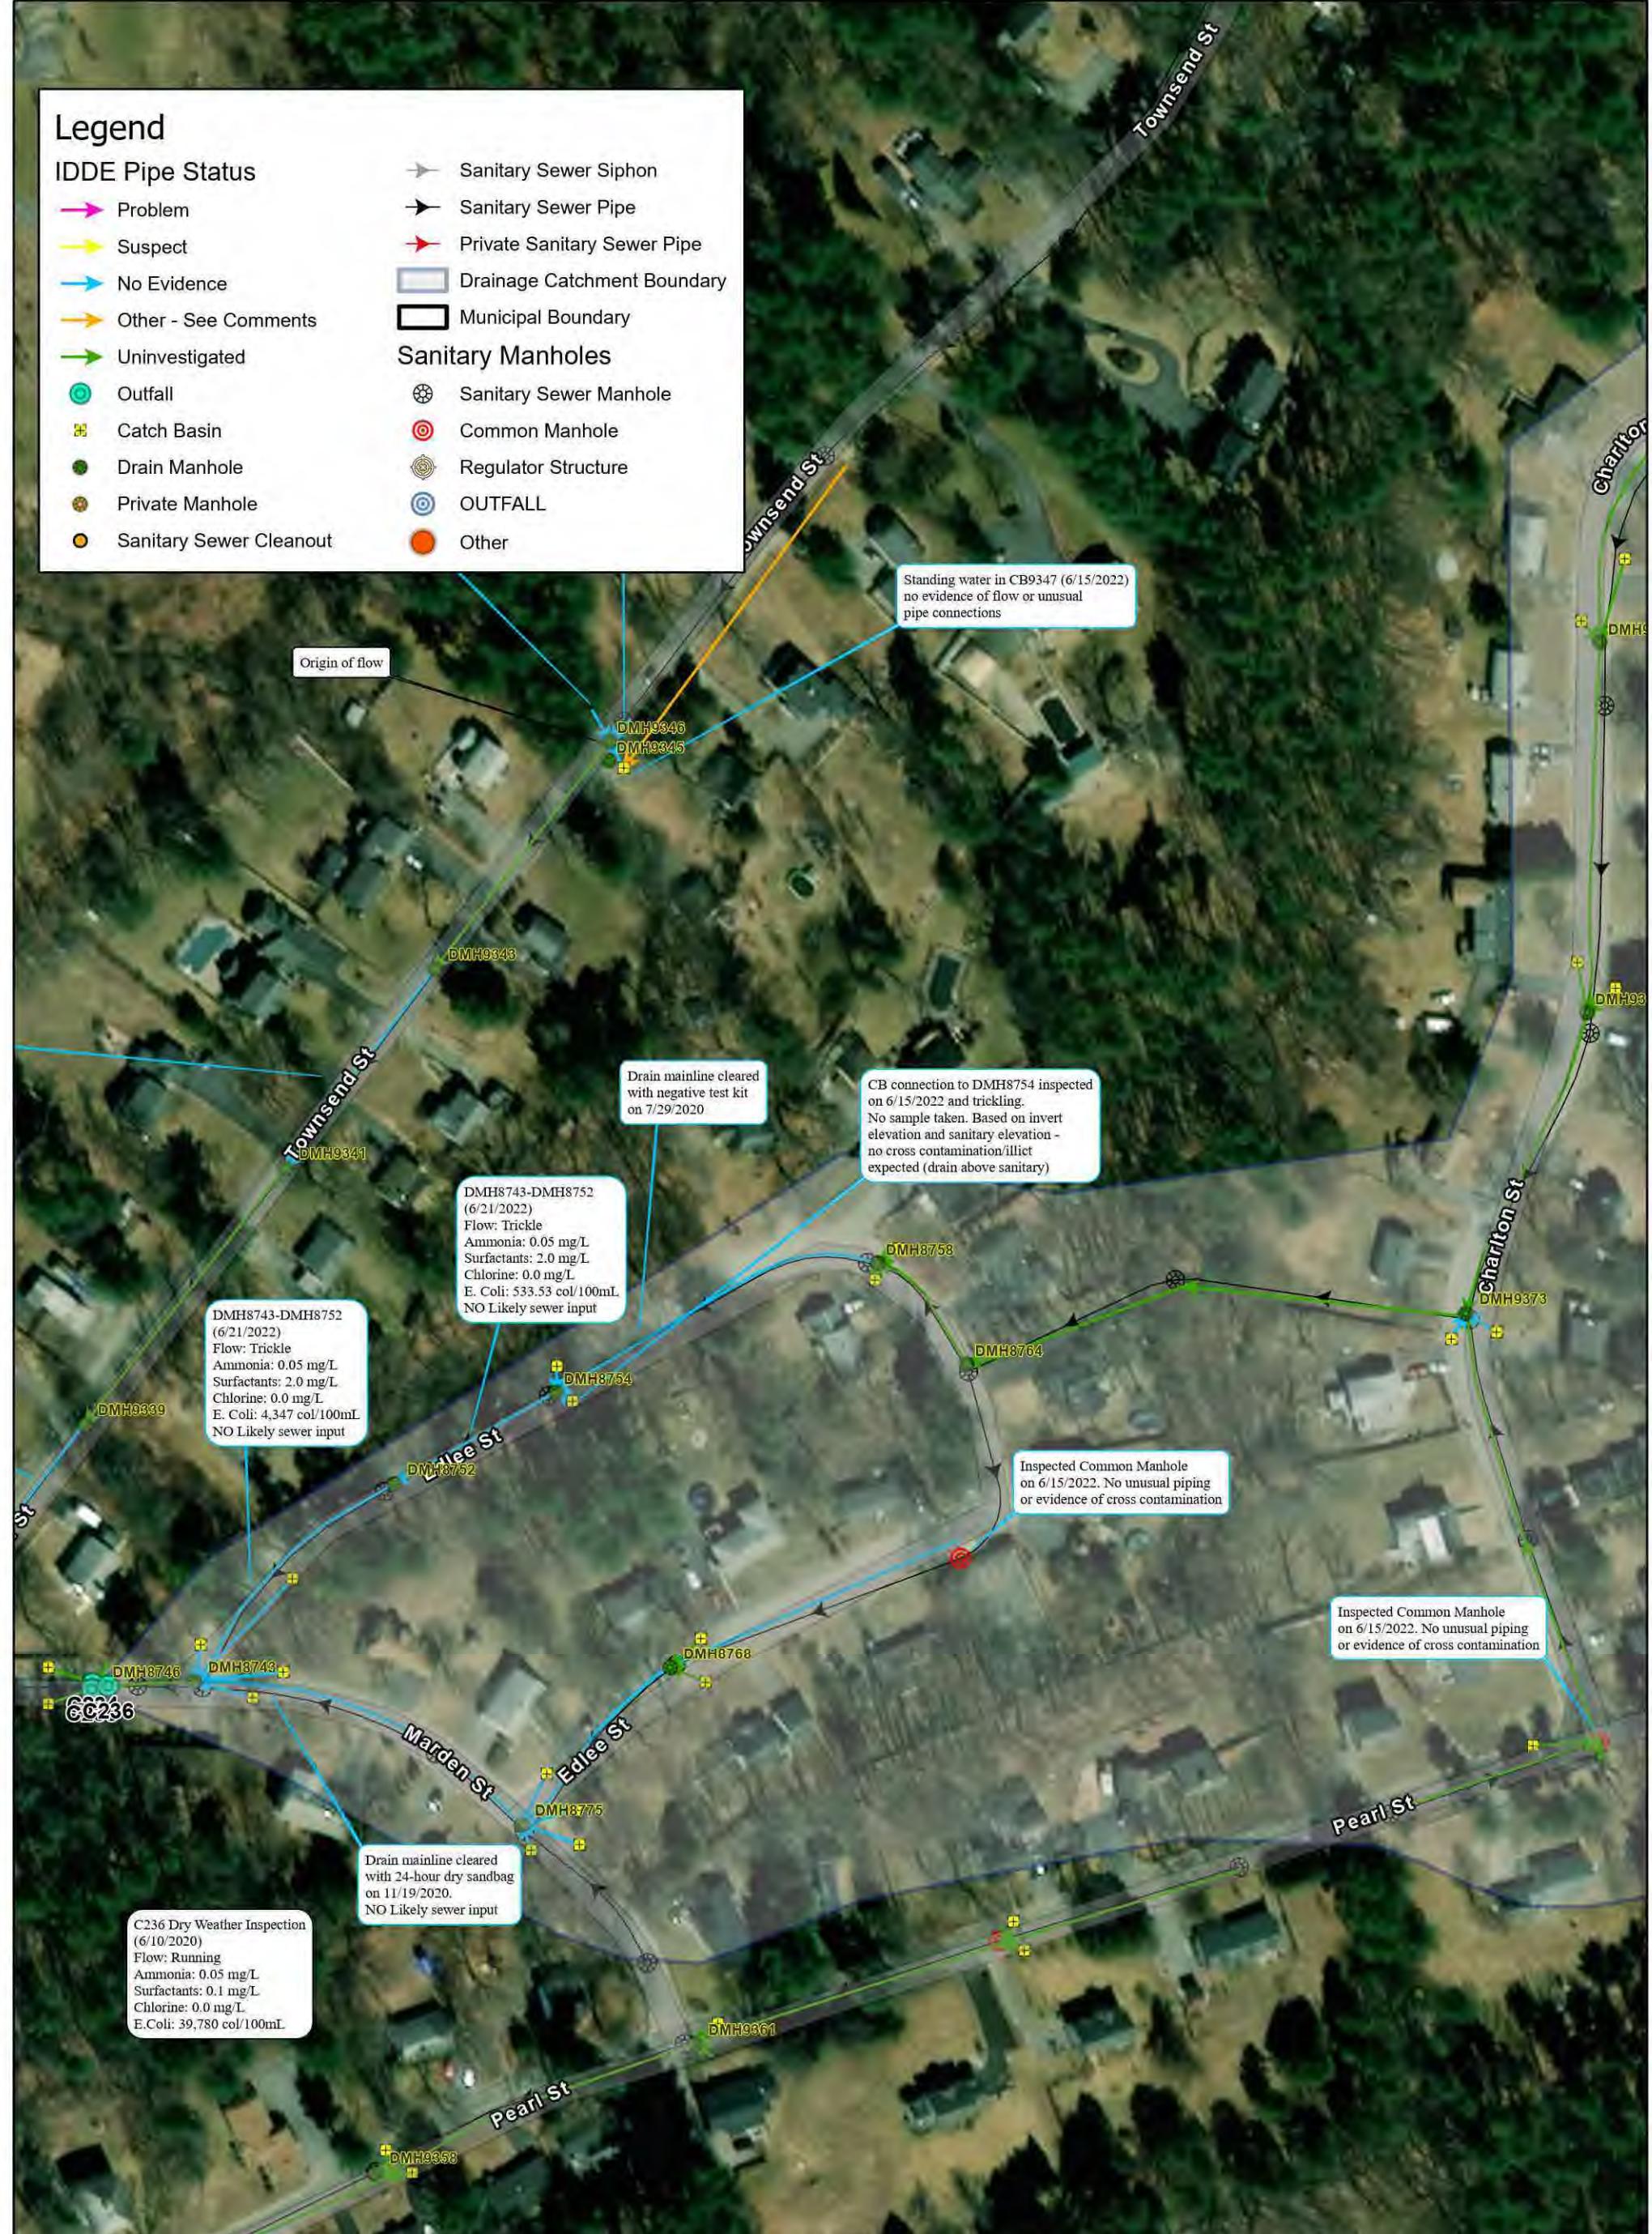
City of Fitchburg, Massachusetts
 NPDES MS4 Compliance
 Illicit Discharge Detection and Elimination (IDDE) Program
 Catchment Area C236 Pipe Inspection Database
 Catchment Status: COMPLETED - No Illicit Detected

C236	DMH8743	MARDEN ST	DMH8770	DMH8770-DMH8743	7/29/20	12	VCP	Dry	48h Sandbag - Dry									No Evidence	
C236	DMH8743	MARDEN ST	CB8749	CB8749-DMH8743	7/29/20	10	VCP	Dry	General Observation									Uninvestigated	Observed Dry, pipe does not cross sanitary system
C236	DMH8743	MARDEN ST	DMH8746	DMH8743-DMH8746	7/29/20	15	VCP	Flow - Running	General Observation									Other - See Comments	Outlet pipe
C236	DMH8754	EDLEE ST	DMH8758	DMH8758-DMH8754	7/29/20	15	VCP	Flow - Running	Sampled Flow	0.00	0.20	0.00	69.4	7.40	0.20	551.0		No Evidence	
C236	DMH8754	EDLEE ST	CB8756	CB8756-DMH8754	7/29/20	10	VCP	Dry	General Observation									No Evidence	Observed Dry, pipe does not cross sanitary system
C236	DMH8754	EDLEE ST	UNK	UNK-DMH8754	7/29/20	6	CI	Wet - No Flow	General Observation									Uninvestigated	Pipe origin unknown, too small to bag, not enough flow to sample
C236	DMH8754	EDLEE ST	CB8757	CB8757-DMH8754	7/29/20	10	VCP	Dry	48h Sandbag - Displaced									Other - See Comments

C236	DMH8754	EDLEE ST	DMH8752	DMH8754-DMH8752	7/29/20	15	VCP	Flow - Running	General Observation									Other - See Comments	Outlet pipe
C236	DMH8764	EDLEE ST	JCT	JCT-DMH8764	7/29/20	15	VCP	Flow - Running	Sampled Flow	0.10	0.20	0.00	62.8	7.74	0.20	553.0		No Evidence	
C236	DMH8764	EDLEE ST	DMH8758	DMH8764-DMH8758	7/29/20	15	VCP	Flow - Running	General Observation									Other - See Comments	Outlet pipe
C236	DMH8775	MARDEN ST	CB8769	CB8769-DMH8775	7/29/20	10	VCP	Dry	General Observation									No Evidence	Observed Dry, pipe does not cross sanitary system
C236	DMH8775	MARDEN ST	DMH8768	DMH8768-DMH8775	7/29/20	12	VCP	Dry	48h Sandbag - Displaced									Other - See Comments	Sandbag Displaced, attempt to rebag for 48-hours
C236	DMH8775	MARDEN ST	CB8770	CB8770-DMH8775	7/29/20	10	VCP	Dry	48h Sandbag - Dry									No Evidence	
C236	DMH8775	MARDEN ST	CB8772	CB8772-DMH8775	7/29/20	10	VCP	Dry	48h Sandbag - Dry									No Evidence

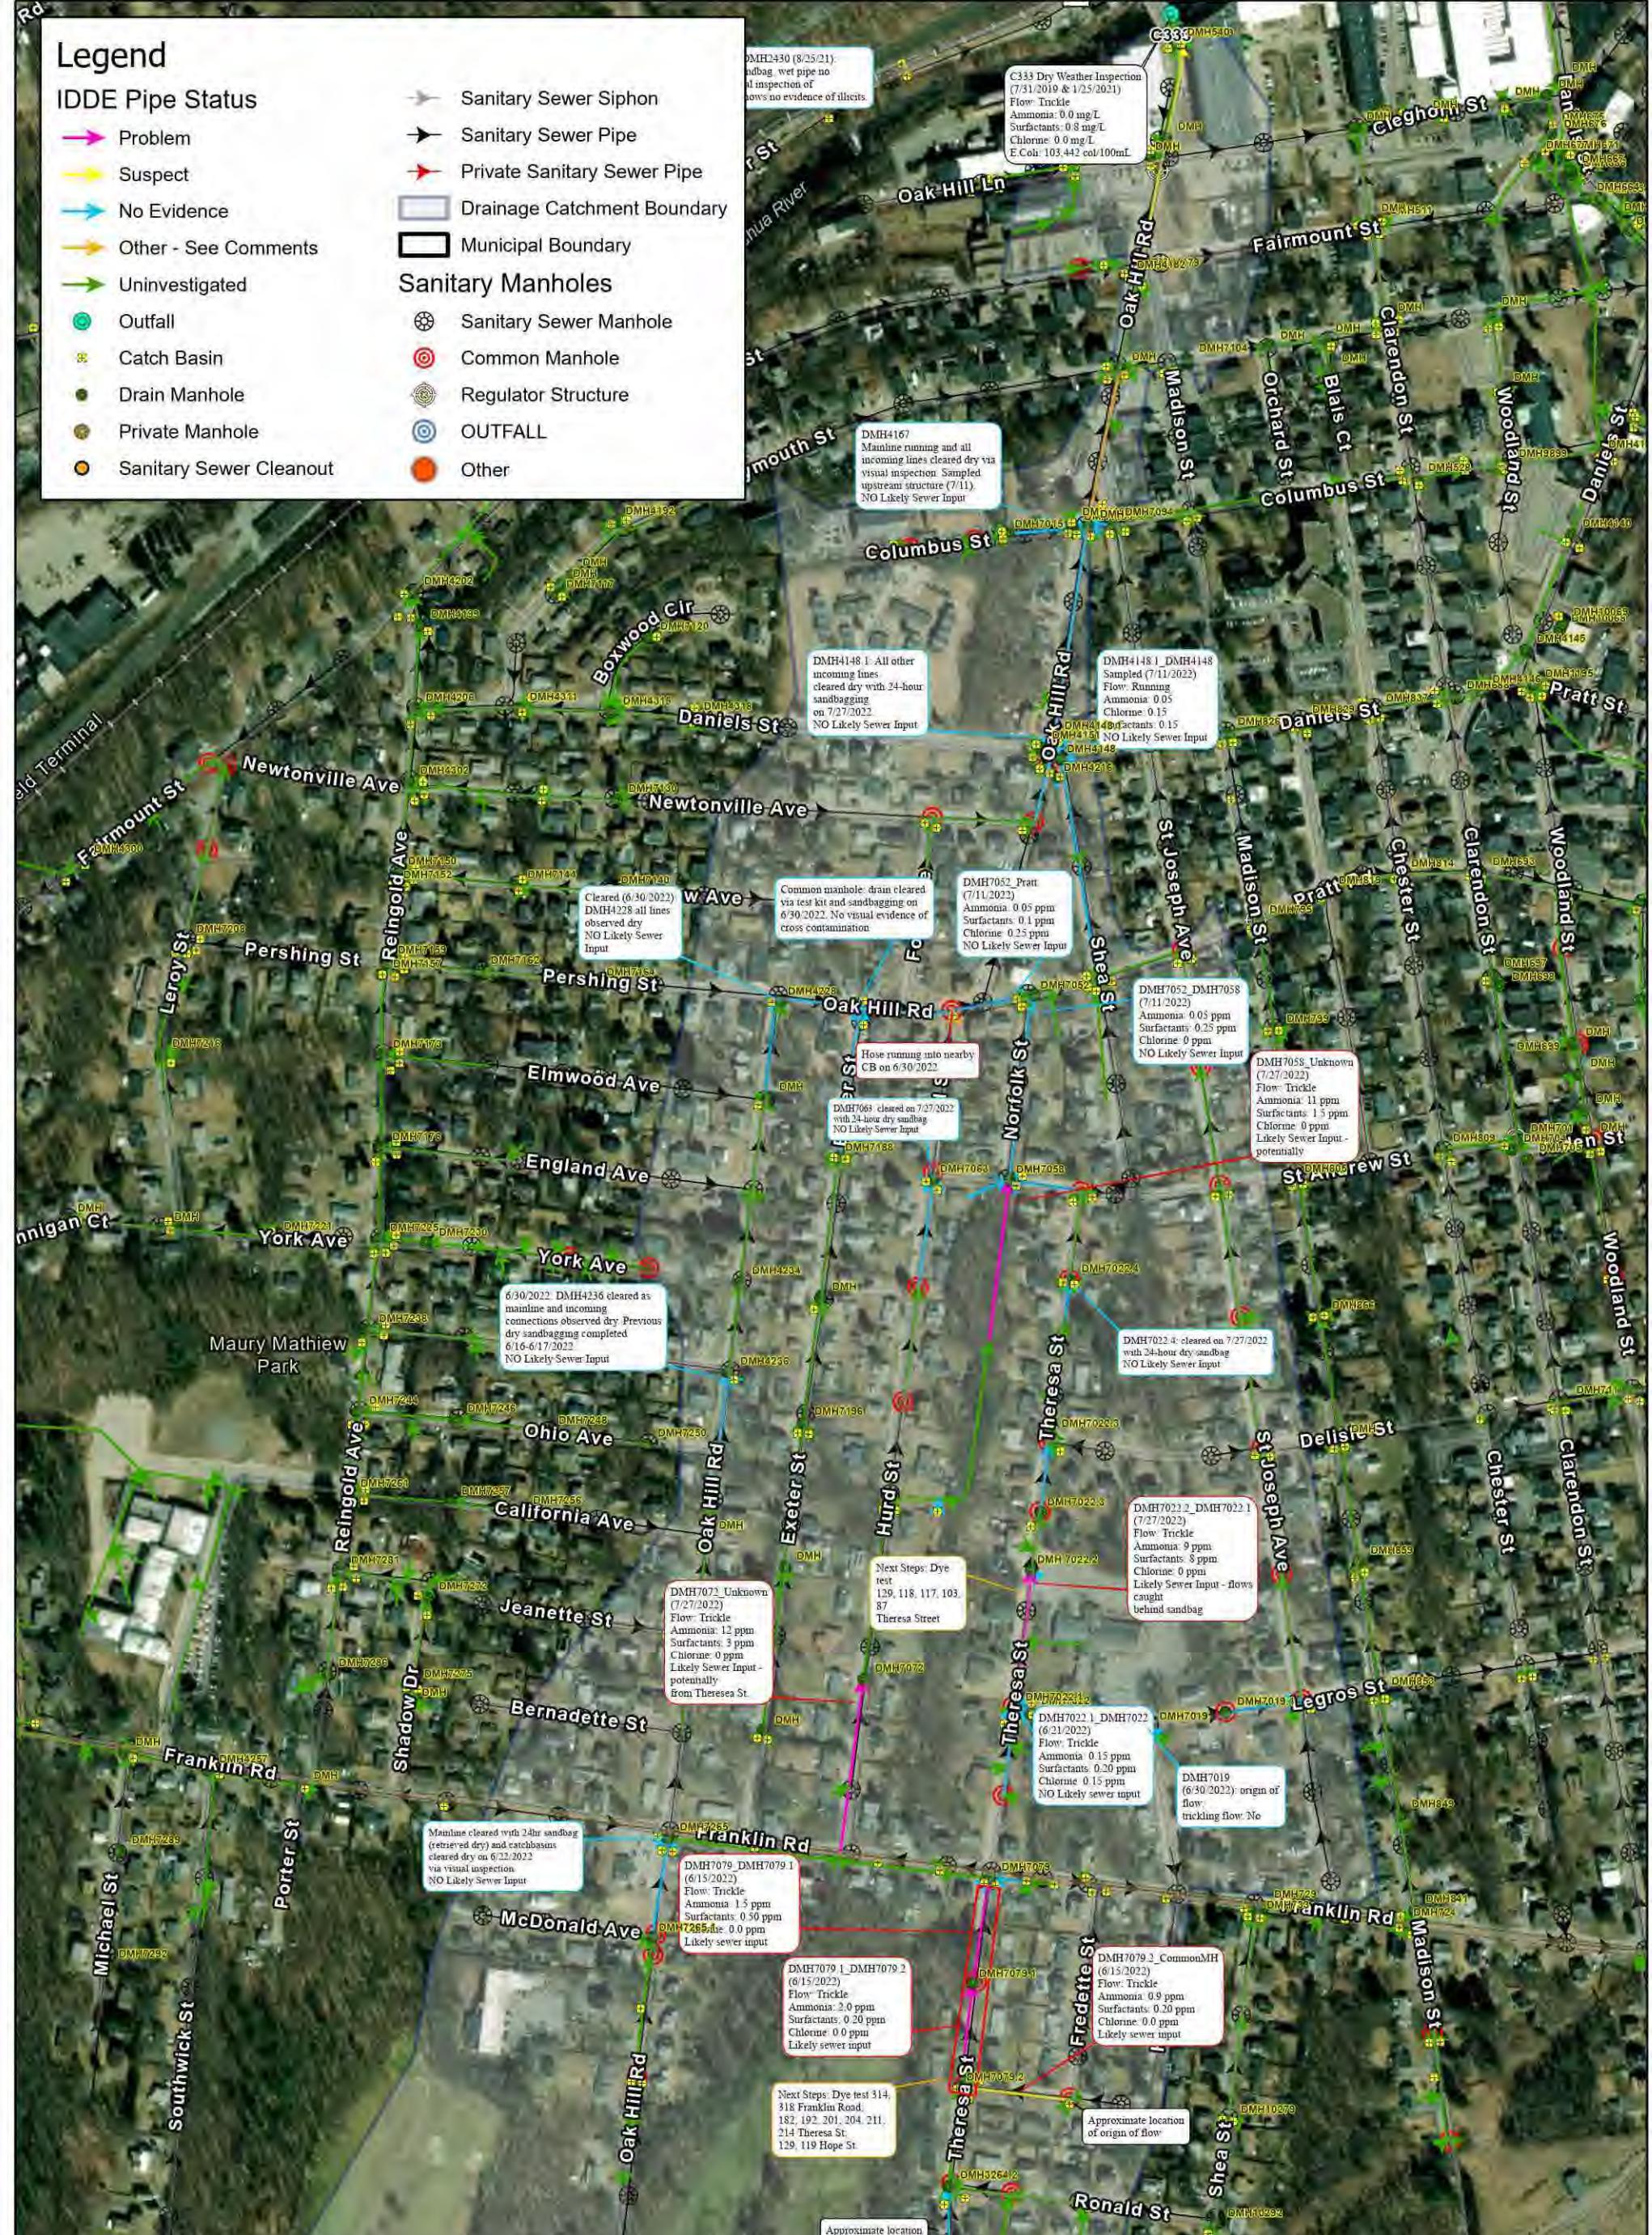
City of Fitchburg, Massachusetts Illicit Discharge Detection & Elimination Program **Catchment Area C333**

C333	6/30/2022	Common Manhole	HURD STREET @ OAK HILL ROAD	CB4225.1	CB4225.1-CommonManhole	UNK	UNK	Dry	Sampled Flow	0	0.15	0.3	70.5	7.53	0.1	194	Other - See Comments	C333; Added separate DMH, no flow observed in pipe none-wet	conditions; but no flow; need to follow-up on upstream flows before
C333	6/30/2022	DMH7022.2	THERESA STREET	DMH7022.1	DMH7022.1-DMH7022.2	12	VC	None - Wet	General Observation								No Evidence	C333; Added separate DMH, no flow observed in pipe none-wet	conditions; clearing.
C333	6/30/2022	DMH7022.2	THERESA STREET	DMH7022.2	DMH7022.2-DMH7022.3	12	VC	None - Wet	General Observation								No Evidence	C333; Added separate DMH, no flow observed via PVC pipe but no flow; no unusual pipe connections or evidence of illicit.	
C333	6/30/2022	DMH7022.4	THERESA STREET	CommonManhole @ Theresa /St Andrew	DMH7022.4-CommonManhole	12	VC	None - Wet	General Observation								No Evidence	C333; Plugged former common manhole, no nearby CB5 or	connections. Mainline is none-wet.

C333	6/30/2022	DMH7022.3	THERESA STREET	DMH7022.4	DMH7022.3-DMH7022.4	12	VC	Dry	General Observation								No Evidence	C333; Plugged former common manhole no longer in use.	
C333	6/30/2022	DMH7022.4	THERESA STREET	DMH7022.3	DMH7022.3-DMH7022.4	12	VC	None - Wet	General Observation								No Evidence	C333; Mapping update 6/30. Separated storm and sanitary. None-wet	observed and noted as upstream trickling flow was sampled.
C333	6/30/2022	DMH7022.4	THERESA STREET	DMH7022.3	DMH7022.3-DMH7022.4	12	VC	Dry	General Observation								No Evidence	C333; Mapping update 6/30. Separated storm and sanitary. None-wet	observed and noted as upstream trickling flow was sampled.
C333	6/30/2022	DMH7019.1	SHEA STREET @ LEGROS STREET	UNK	DMH7019.1-UNK	UNK	UNK	Dry	General Observation								No Evidence	C333; Investigated to confirm no connection Theresa Rd line; dry-no	flow cleared but not part of C333 being investigated

C333	6/30/2022	DMH7019	HOPE STREET @ LEGROS STREET	UNK	UNK-DMH7019	UNK	UNK	Flow - Trickling	General Observation								No Evidence	C333; Very slow flow coming in, unsure of where this flow comes from	as mapping stops and confirmed that other end of Legros does not connect. 2 incoming CB connections are dry.
C333	6/30/2022	DMH7019	EXETER STREET @ OAK HILL ROAD	DMH7188	DMH7188-CommonManhole	12	VC	Flow - Running	Sampled Flow	0	0.1	0	74.3	7.2	0.1	300	No Evidence	C333; Sampled Exeter St Line (main line had flow; no flow from connecting CB); sample results did not indicate major issue, potentially groundwater

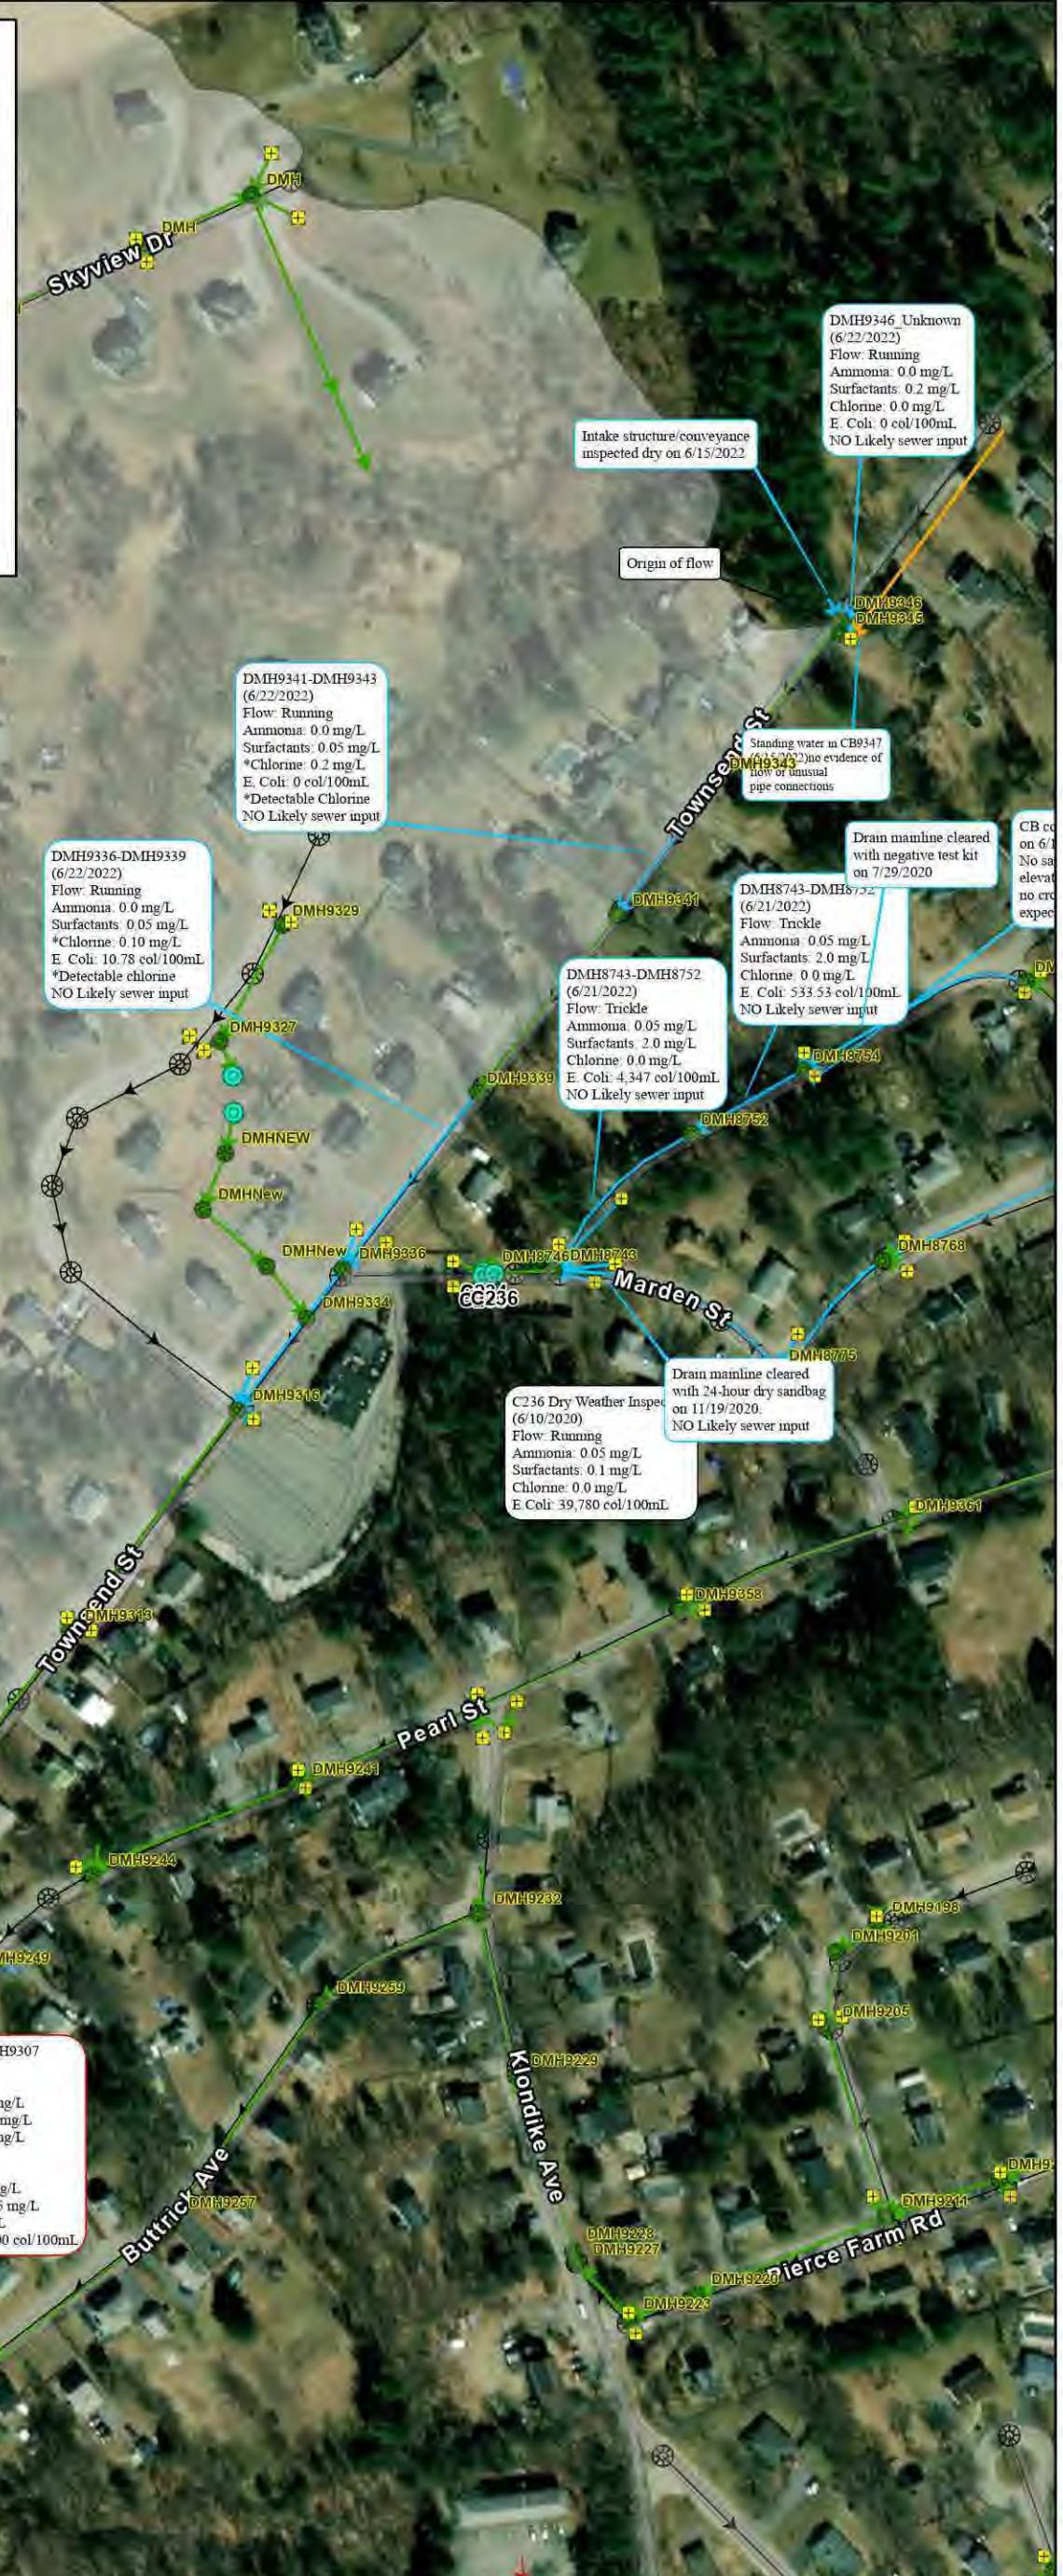
City of Fitchburg, Massachusetts Illicit Discharge Detection & Elimination Program **Catchment Area C404**

C404	DMH9316	6/15/2022	48	0.3	TOWNSEND STREET @ ETHIER STREET	CB9317	CB9317-DMH9316	12	VC	Dry	General Observation									No Evidence	C404; CB9317 observed dry and no flow into DMH9316
C404	DMH9341	6/15/2022	48	0.03	TOWNSEND STREET	DMH9343	DMH9343-DMH9341	18	RCP	Flow - Running	Sampled Flow	0	0.1	0.25	68.8	7.21	0	170		No Evidence	C404; detectable chlorine. both catch basins are dry
C404	DMH9346	6/15/2022	48	0.03	TOWNSEND STREET	DMH9345	DMH9346-DMH9345	30	RCP	Dry	General Observation									No Evidence	C404; Intake/conveyance line dry. No sand bag placed visually inspected dry
C404	DMH9336	6/21/2022	35	0.23	TOWNSEND STREET @ MARDEN STREET	CB9337	CB9337-DMH9336	12	RCP	Dry	General Observation									No Evidence	C404; CB cleared dry via visual inspection; no flow into DMH9336.
C404	DMH9336	6/21/2022	35	0.23	TOWNSEND STREET @ MARDEN STREET	CB9338	CB9338-DMH9336	12	RCP	Dry	General Observation									No Evidence	C404; CB cleared via visual inspection; no flow into DMH9336

C404	DMH9304	6/21/2022	35	0.23	TOWNSEND STREET @ MARSHALL ROAD	DMH9307	DMH9307-DMH9304	30	RCP	Flow - Running	Sampled Flow	0.6	0.3	0	63.6	7.33	0.1	237		Suspect	C404
C404	DMH9304	6/21/2022	35	0.23	TOWNSEND STREET @ MARSHALL ROAD	DMH Marshall Rd	DMH Marshall Rd-DMH9304	12	VC	Dry	General Observation									No Evidence	C404; Observed dry. Previously sandbagged and dry in 2019
C404	DMH9346	6/22/2022	60	0.23	TOWNSEND STREET	DMH9343	DMH9346-DMH9343	18	RCP	Flow - Trickling	Sampled Flow	0	0.15	0	59	6.83	0.1	209		No Evidence	C404
C404	DMH9341	6/22/2022	60	0.23	TOWNSEND STREET	DMH9343	DMH9343-DMH9341	18	RCP	Flow - Running	Sampled Flow	0	0.05	0.2	61.5	7.38	0	141.9	0	No Evidence	C404; Running Water (faster than 9346 and 9343; bacteria results came back as 0, reducing likelihood of illicit source (likely groundwater)
C404	DMH9336	6/22/2022	60	0.23	TOWNSEND STREET @ MARDEN STREET	DMH9339	DMH9339-DMH9336	24	RCP	Flow - Running	Sampled Flow	0	0.05	0.1	61	7.2	0.1	206	10.78	No Evidence	C404, Both Catch Basins are Dry

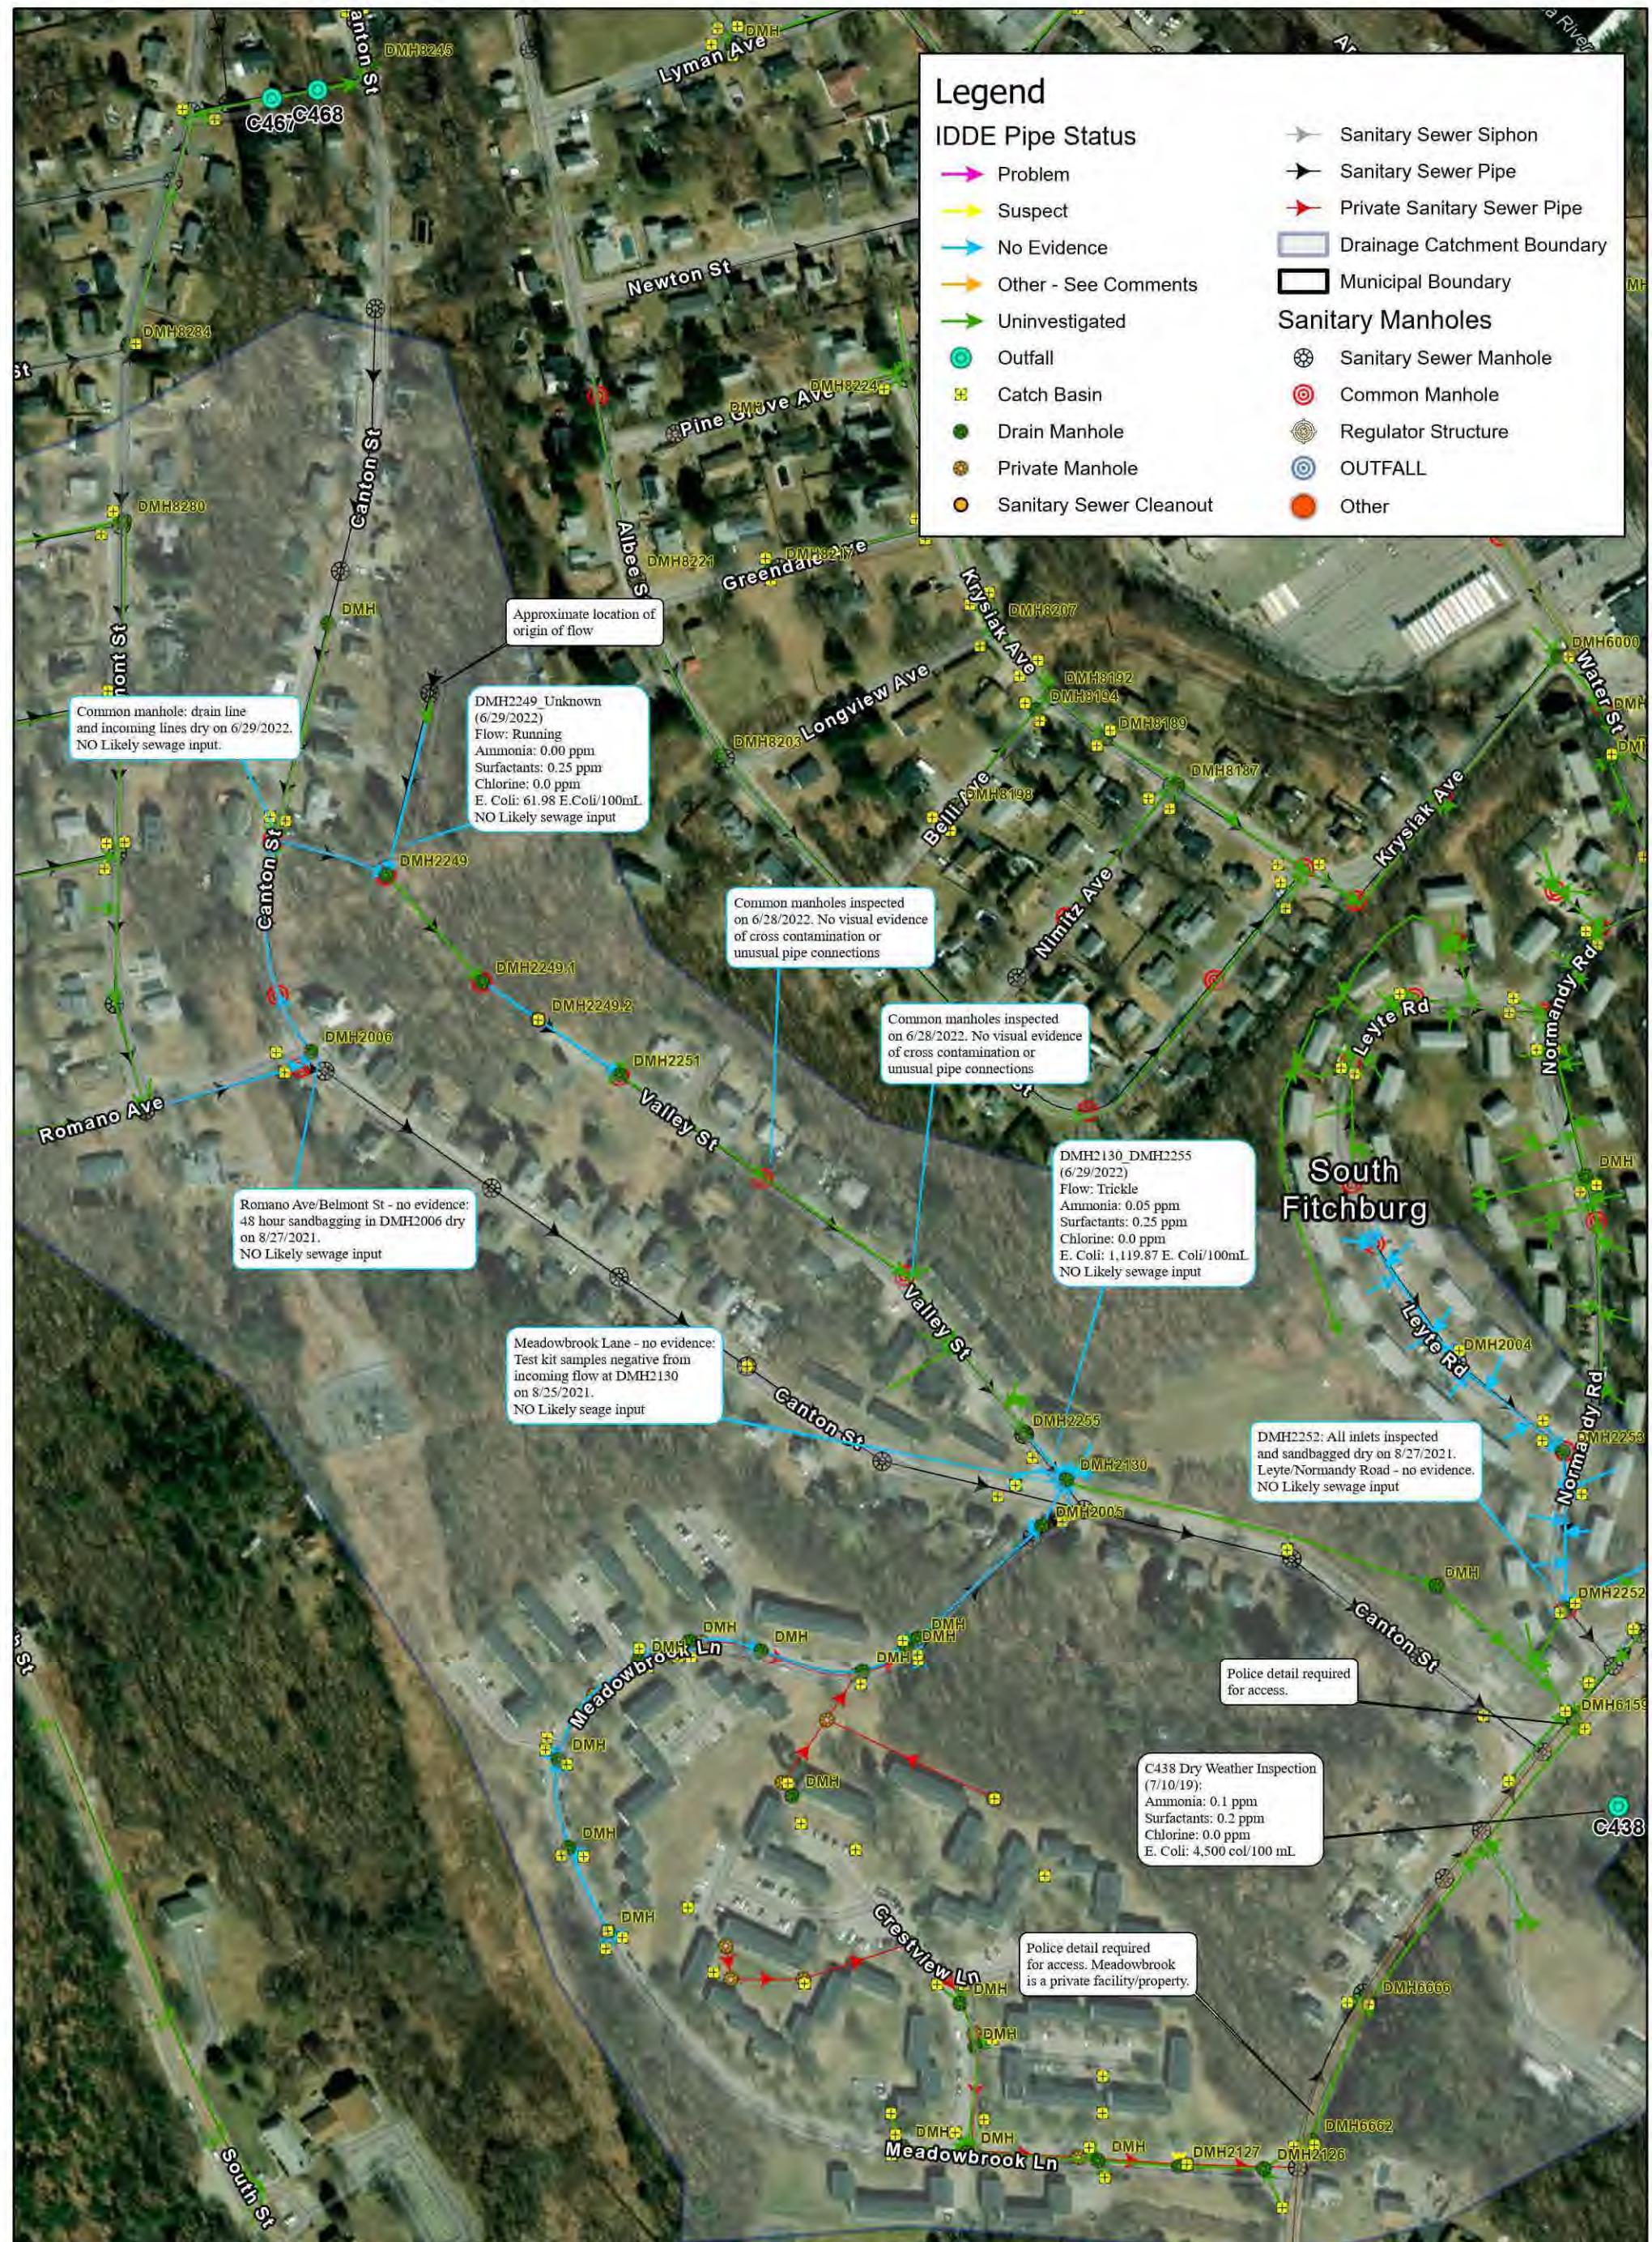
City of Fitchburg, Massachusetts Illicit Discharge Detection & Elimination Program Catchment Area C438

Catchment Area	Access Point StructureID	Street / Location	Inlet/Direction	Connecting Structure ID	Inspection Date	Flow Conditions	Investigation Type	Ammonia (ppm)	Surfactants (ppm)	Chlorine (ppm)	Temp (°F)	pH	Salinity (ppt)	Specific Conductivity (µS)	E. coli (col/100ml)	Status	Comments
C438	DMH2004	LEYTE ROAD	Inlet	UNK	8/25/2021	Dry	Sandbag - 48h									No Evidence	C438; Need to re-map pipe to other side of manhole. Sandbag placed. Return for sandbag on 8/27. Sandbag and pipe dry on 8/27.
C438	DMH2004	LEYTE ROAD	Inlet	CB6872	8/25/2021	Dry	General Observation									No Evidence	C438; Inspected dry and cleared. Cannot place sandbag due to proximity of other inlet pipes.
C438	DMH2004	LEYTE ROAD	Inlet	Common on Leyte Rd	8/25/2021	None - Wet	General Observation									No Evidence	C438; Standing water in manhole. May be due to sag in manhole. No evidence of illicits. Brown and cloudy water observed.

C438	DMH2252	NORMANDY ROAD	Inlet	UNK	8/25/2021	Dry	General Observation									No Evidence	C438; Cannot place sand bag due to angle of pipe. CB6866 visual inspected and no evidence of illicits or unusual pipe connections.
C438	DMH2252	NORMANDY ROAD	Inlet		8/25/2021	CNL inlet	General Observation									No Evidence	C438; CNL inlet line to DMH2252.
C438	DMH2006	CANTON STREET @ ROMANO AVE	Inlet	CB8257	8/27/2021	Dry	Sandbag - 48h									Other - See Comments	C438; 48h sandbag retrieved on 8/27 dry no evidence of flow or illicit. Dried mud deposits observed.
C438	DMH2006	CANTON STREET @ ROMANO AVE	Inlet	CB8257	8/25/2021	Dry	Sandbag - 48h									No Evidence	C438; Will return on 8/27 for sandbag. Dried mud deposits observed.
C438	DMH2006	CANTON STREET @ ROMANO AVE	Outlet	Common on Canton S	8/25/2021											No Evidence	C438
C438	DMH2251	VALLEY STREET	Outlet	Common on Valley S	6/29/2022	None - Standing Water	General Observation									No Evidence	C438
