Fitchburg City Hall

718 Main Street, Fitchburg, Massachusetts

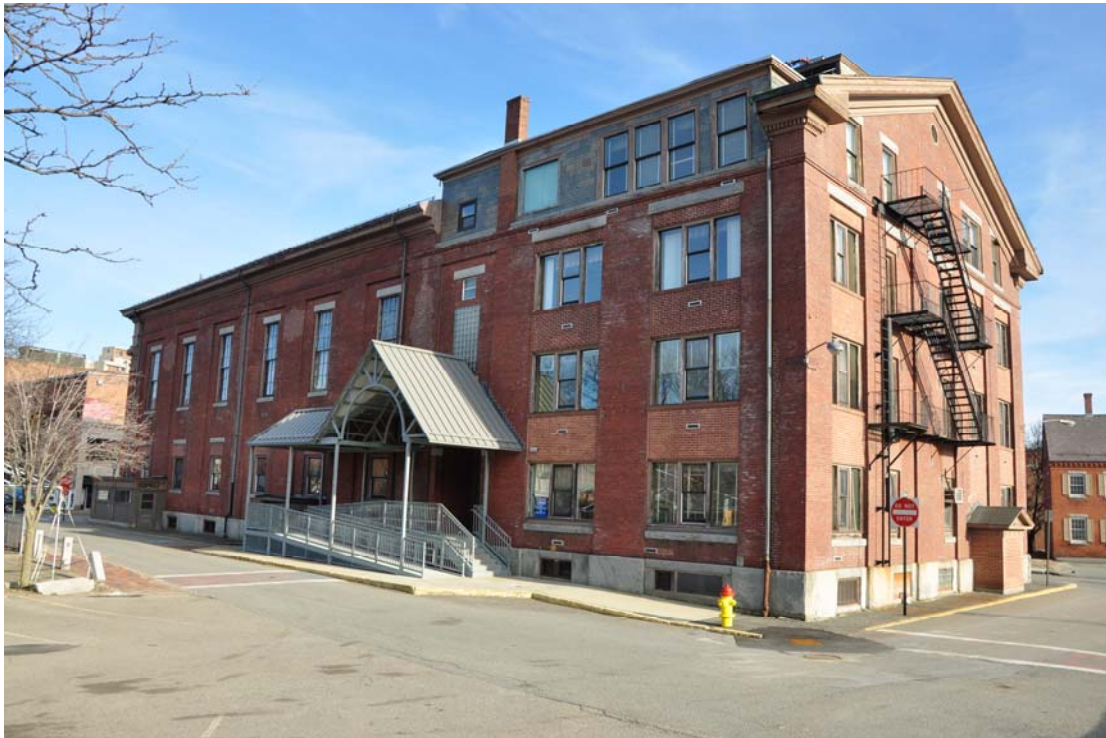
View of exterior from southwest showing existing accessible ramp structure

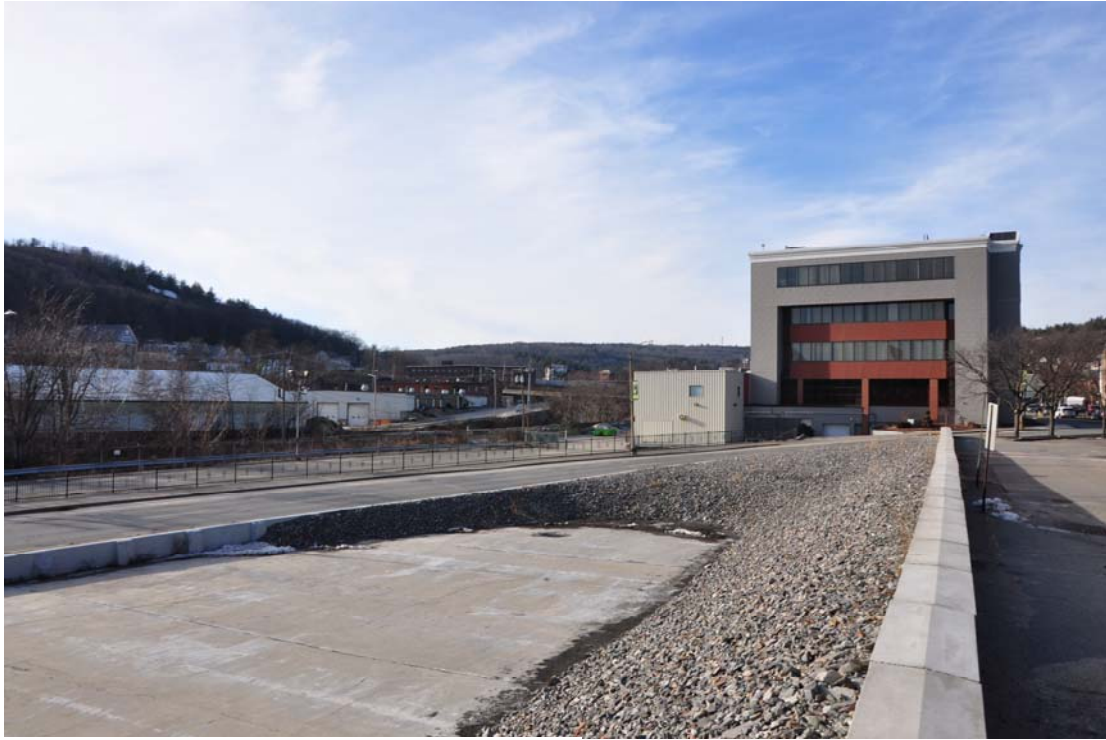
View of demolished parking structure looking west

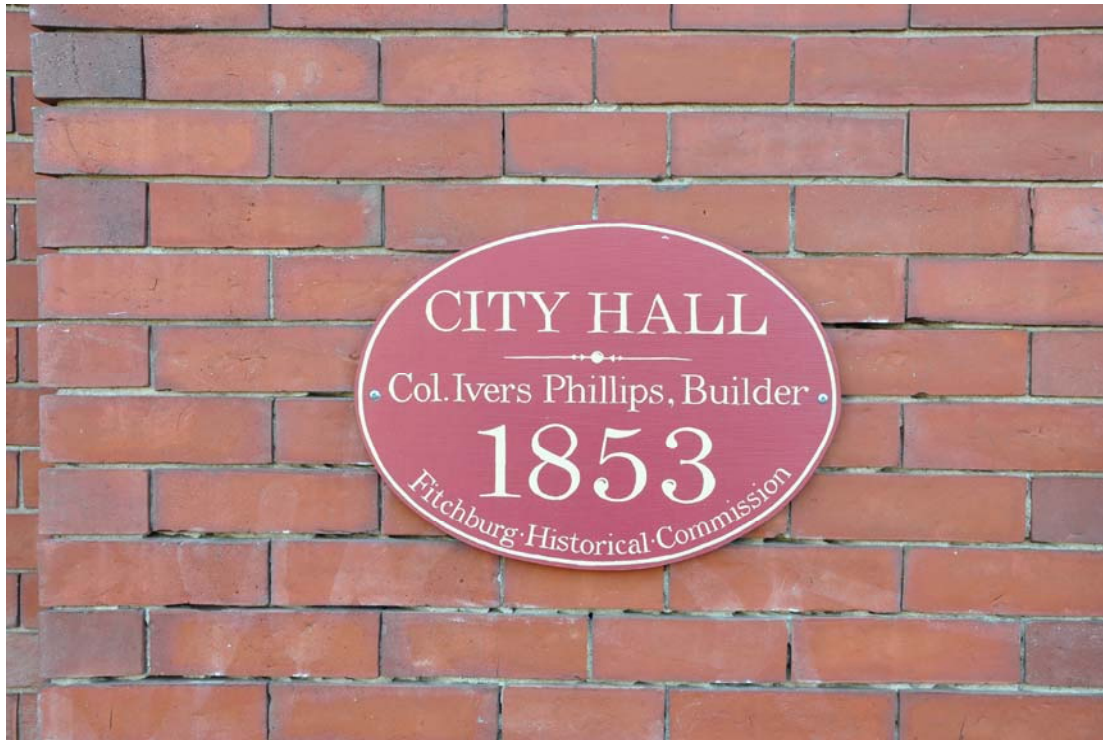
View of typical existing masonry condition requiring repointing

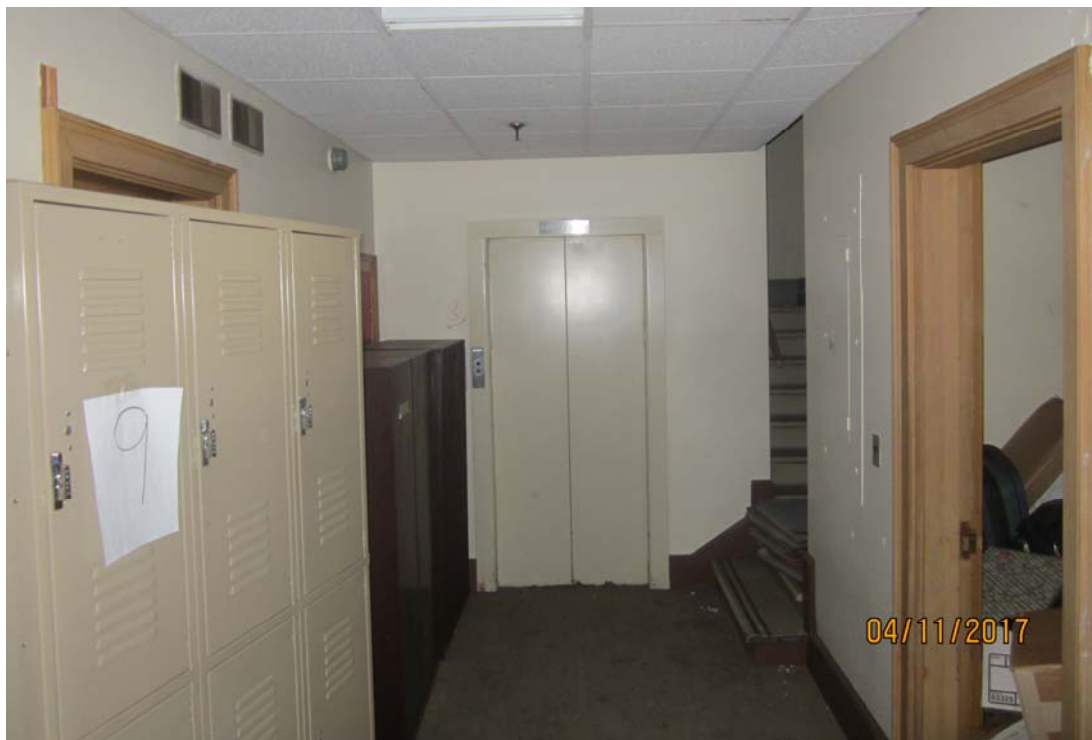
View of interior showing existing elevator and stair

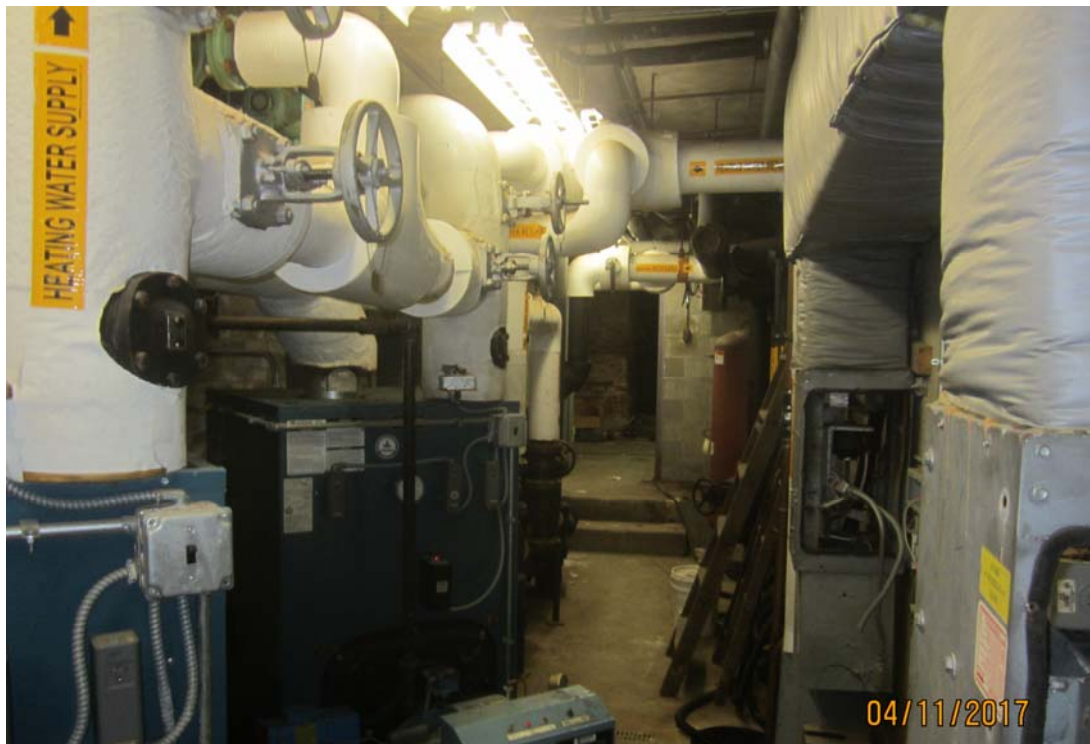
View of existing boiler room

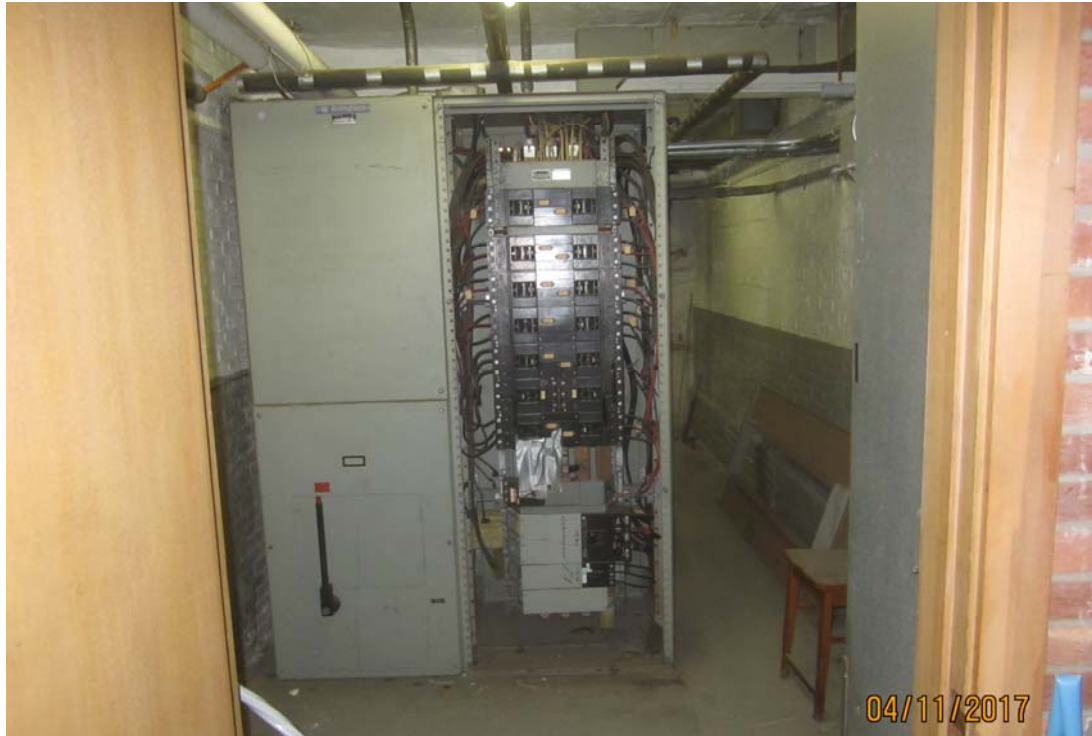
View of existing electrical room

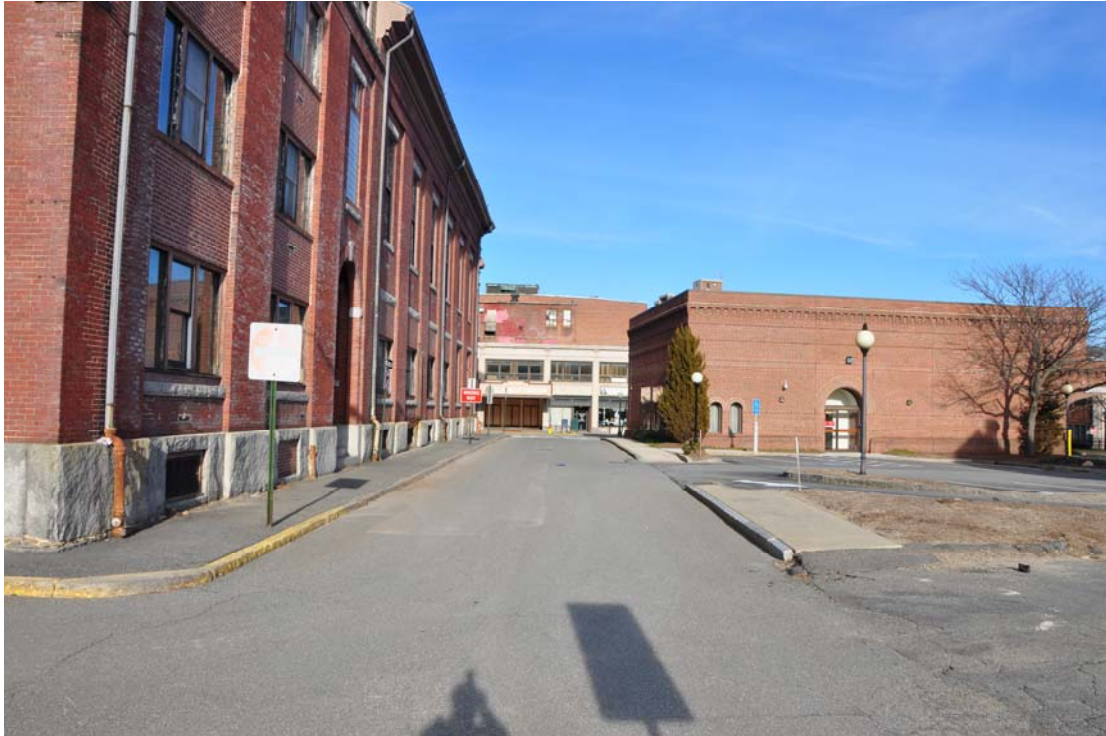
View of exterior looking northeast showing existing paving

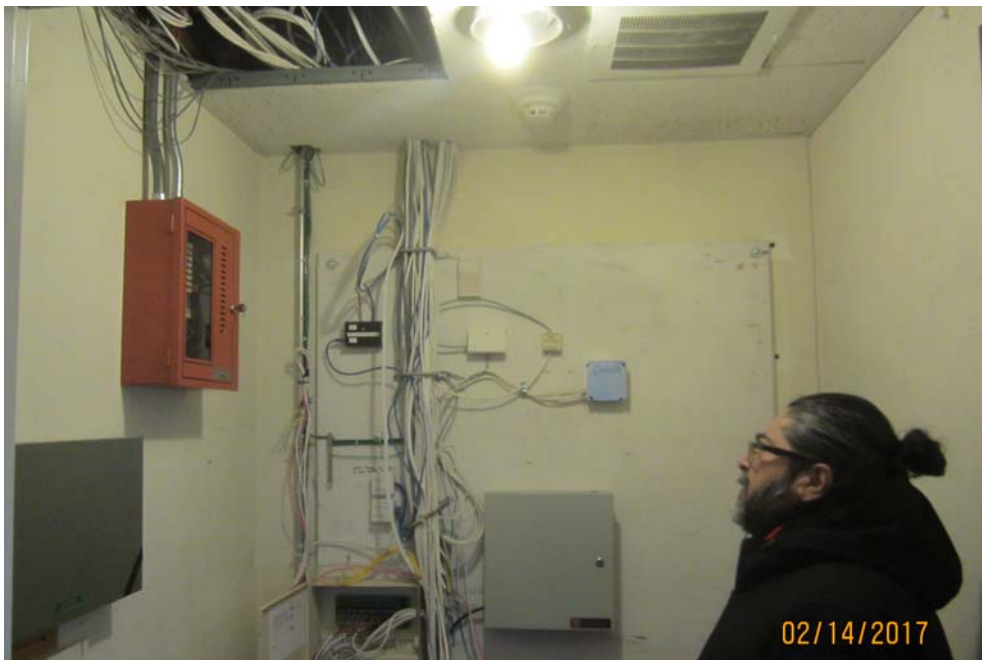
View of bank building existing electrical closet

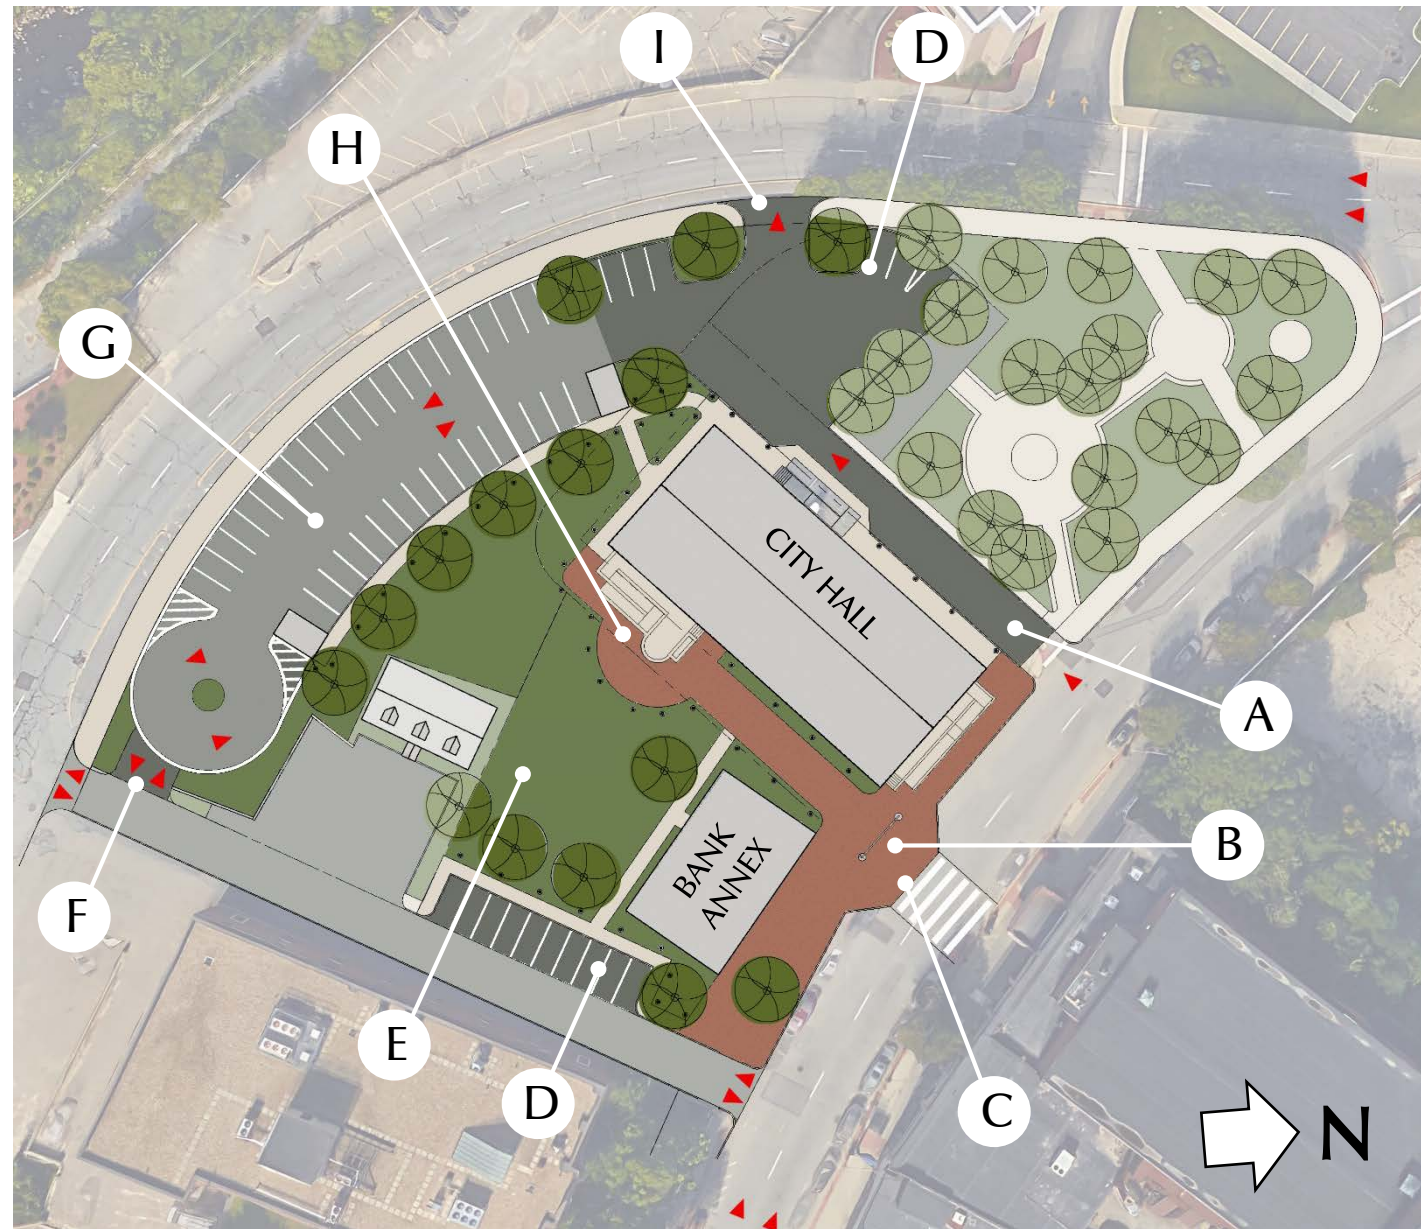
If the bank building and its accompanying site area are not included in the scope of the proposed project development, the site would essentially remain in its current configuration with little improvements. The site circulation would remain as it is currently, only with new paving. The potential opportunity for revitalization of the area through incorporating increased open park space for public activities and interactions would be limited.

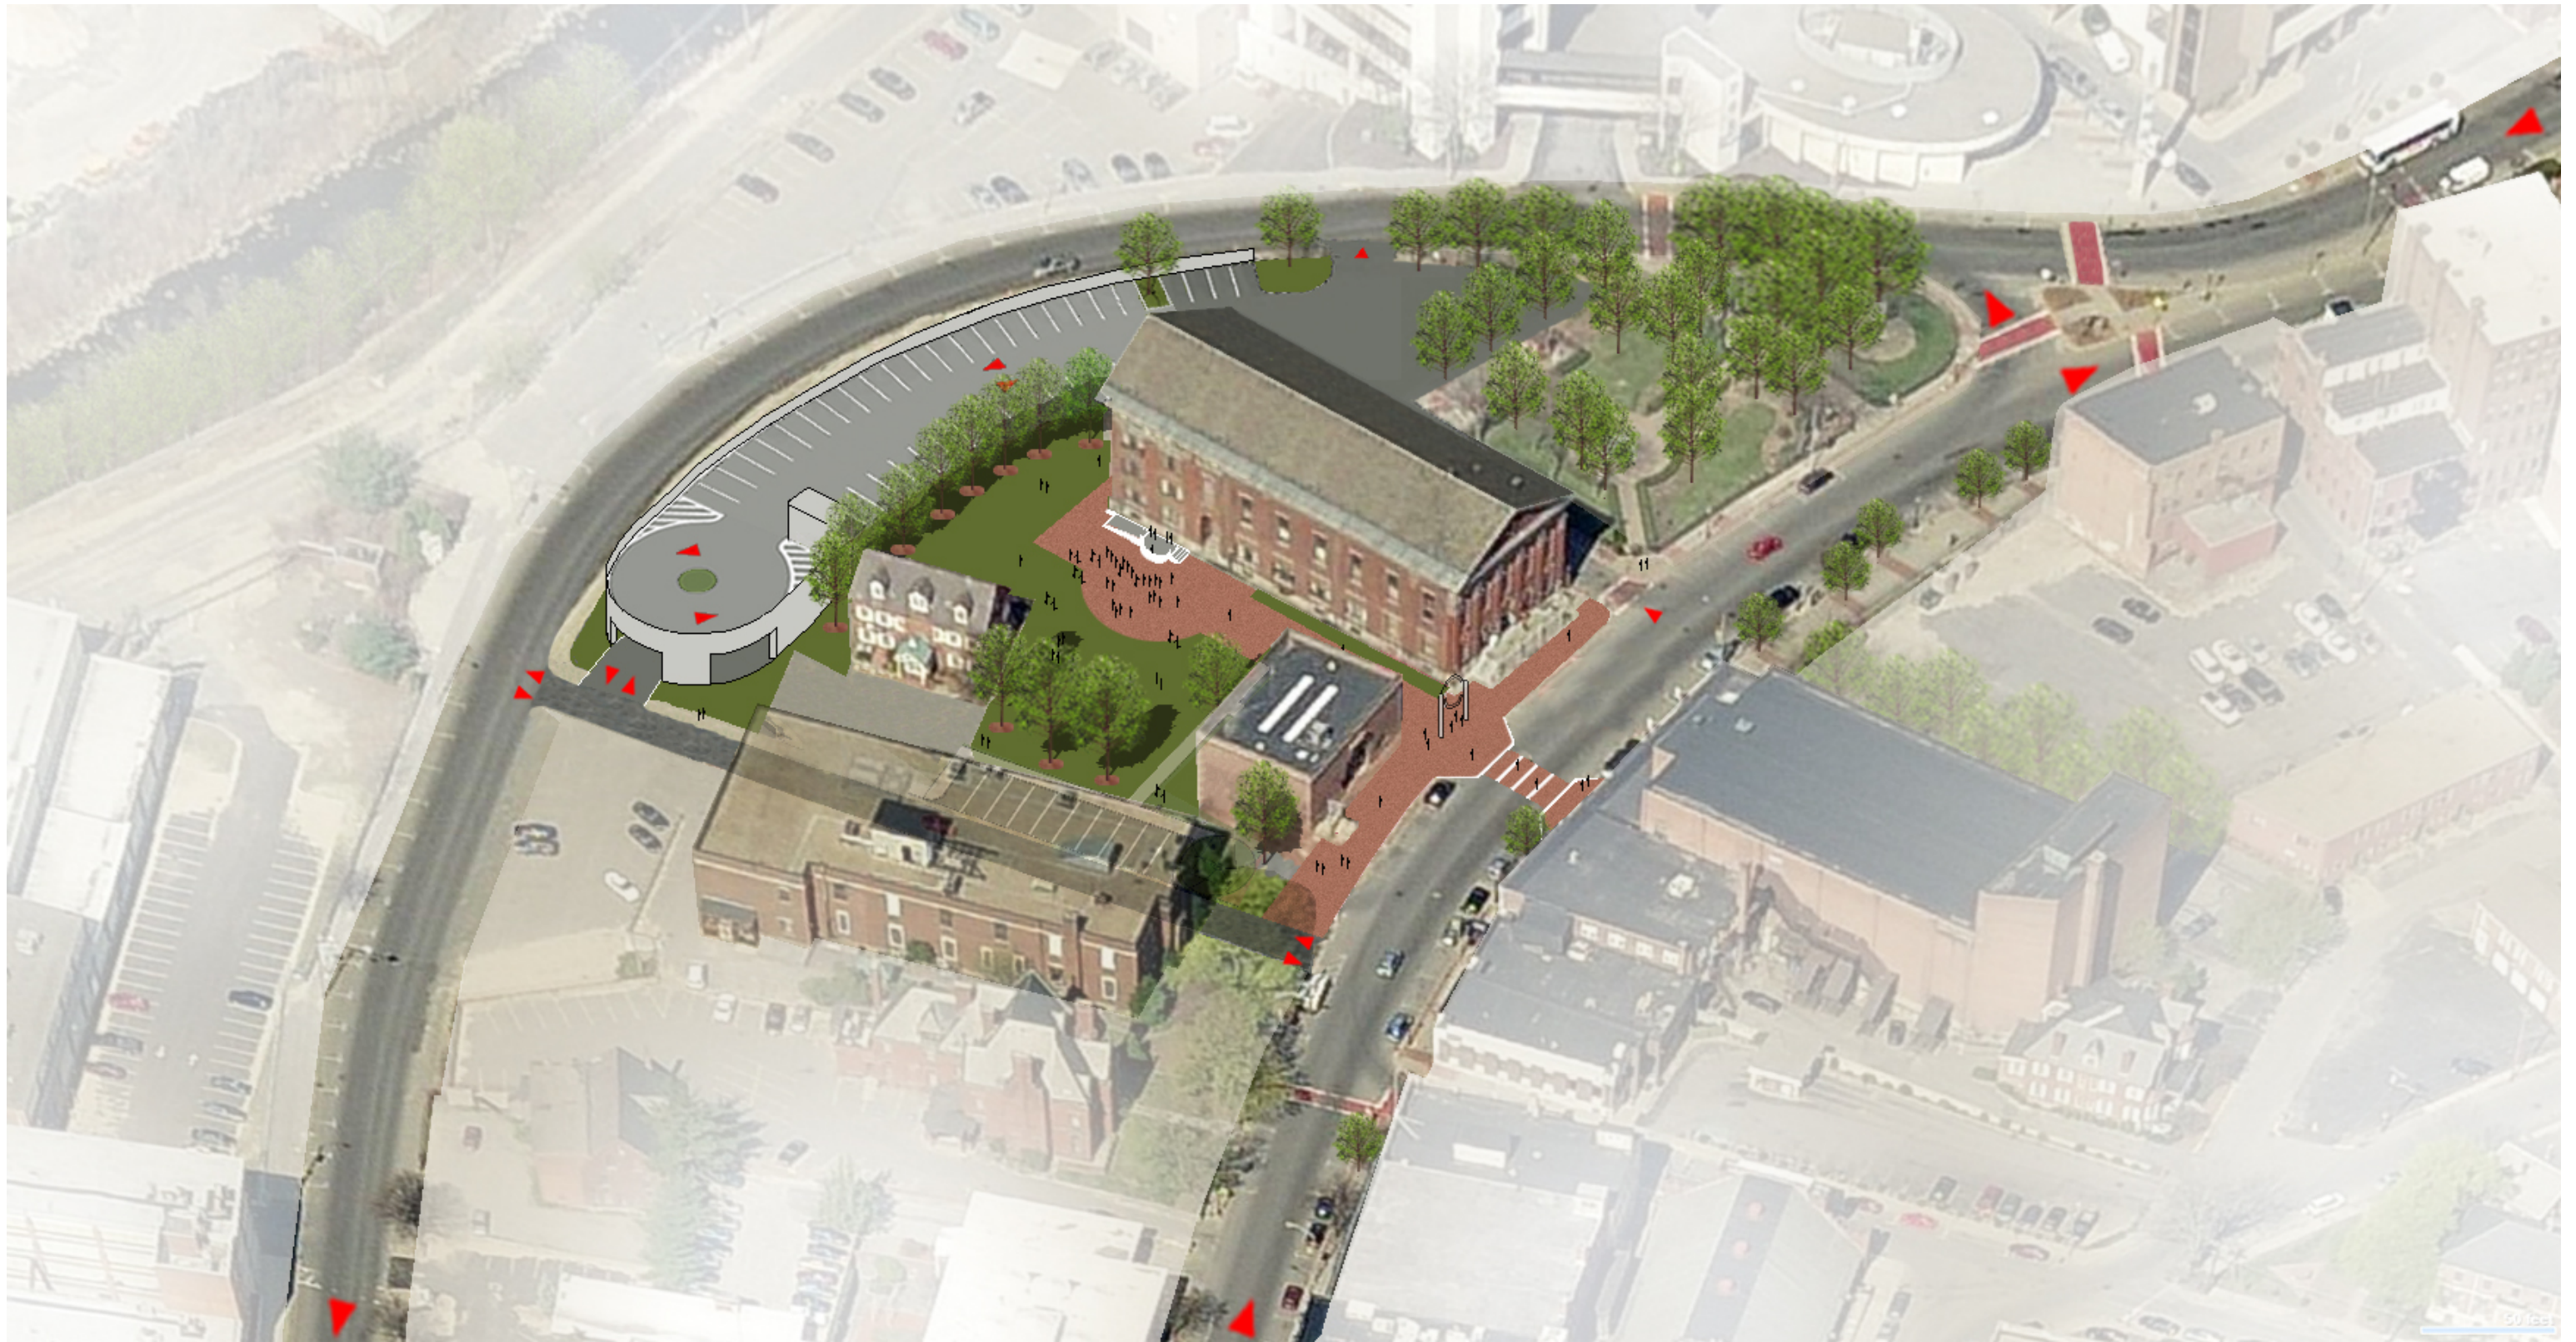
Option 1 – Renovation without the Grand Hall

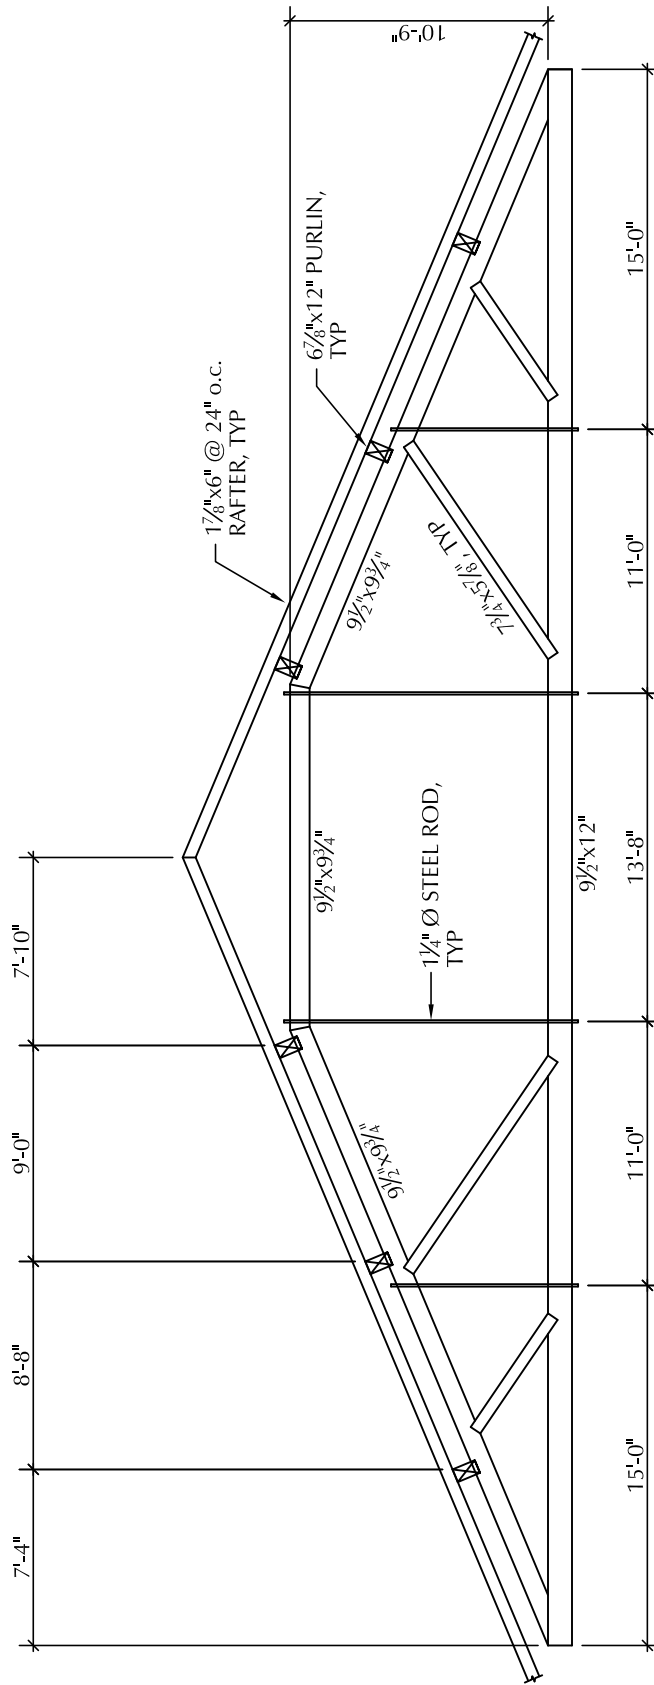
DRAWING NUMBER:
SK-01

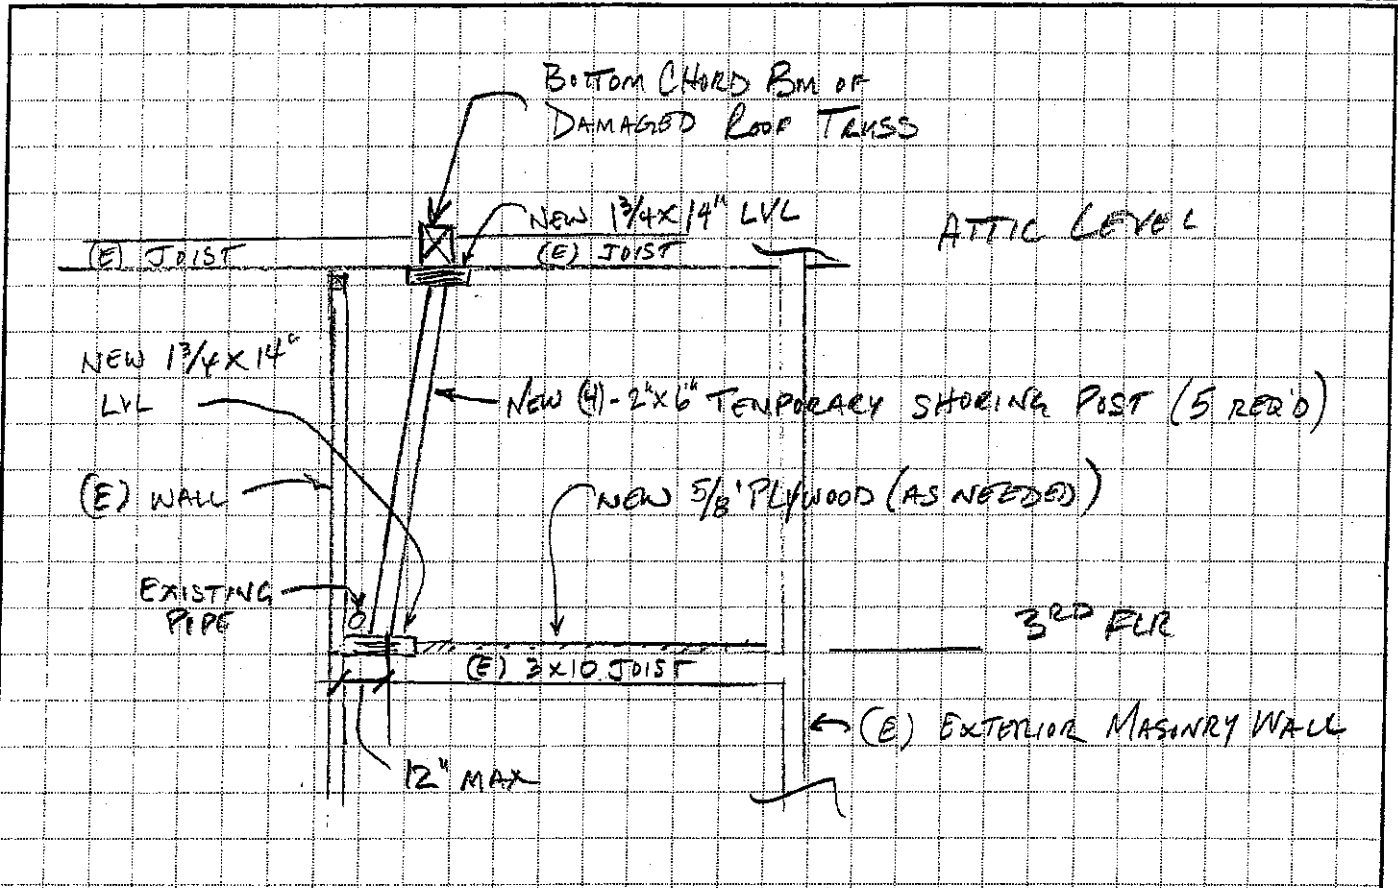
• REMOVE EXISTING CEILING FINISHES AS NEEDED TO ALLOW FOR INSTALLATION OF 1 1/2" LVL DIRECTLY TO UNDERSIDE OF BOTTOM CHORD BEAM OF DAMAGED TRUSS.

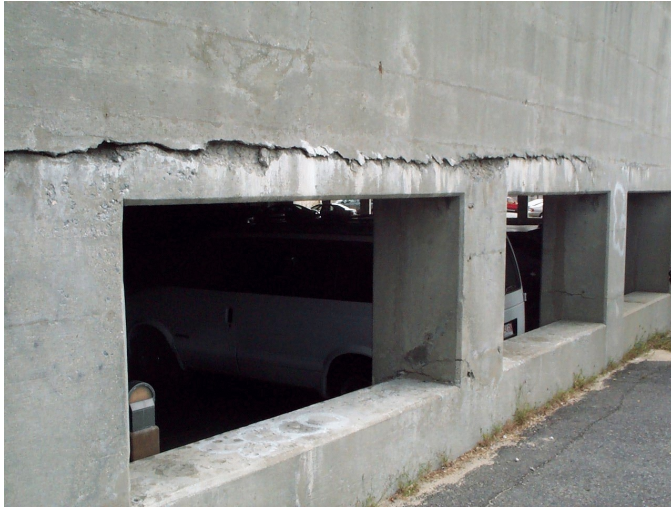
Figure 6: Cracks in spandrel beam of garage.

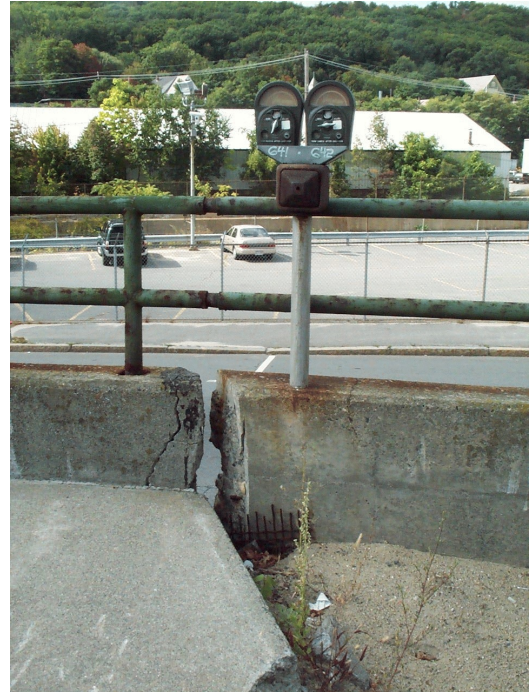
Figure 7: Crack between garage and on-grade parking lot.

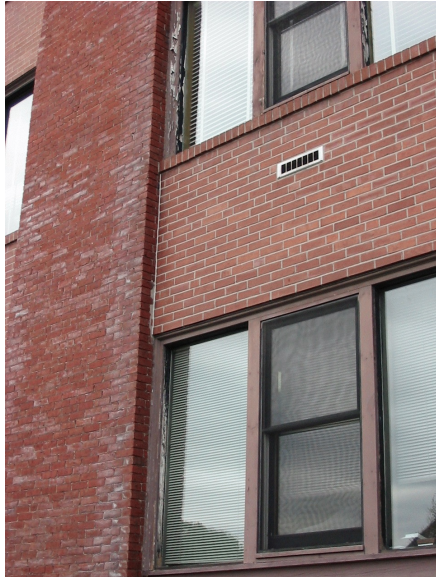
Figure 9: Different types of brick.

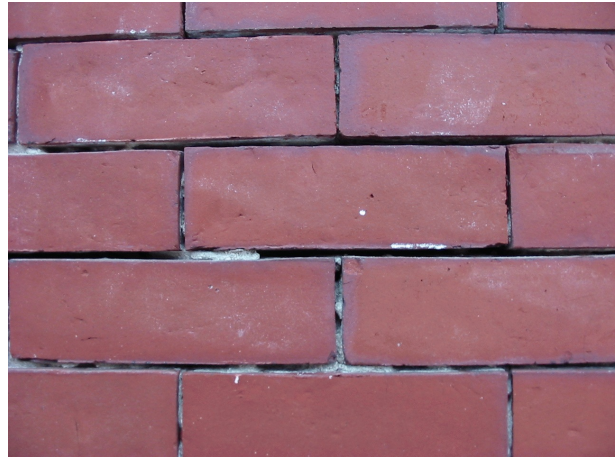
Figure 8: Open mortar joints.

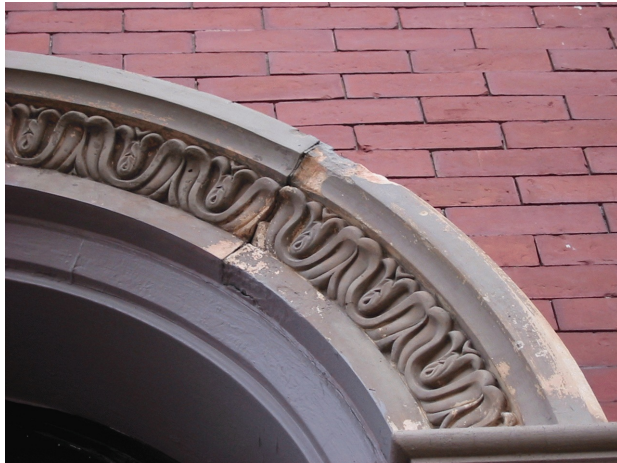
Figure 10: Detailed stone at Main Street entrance.

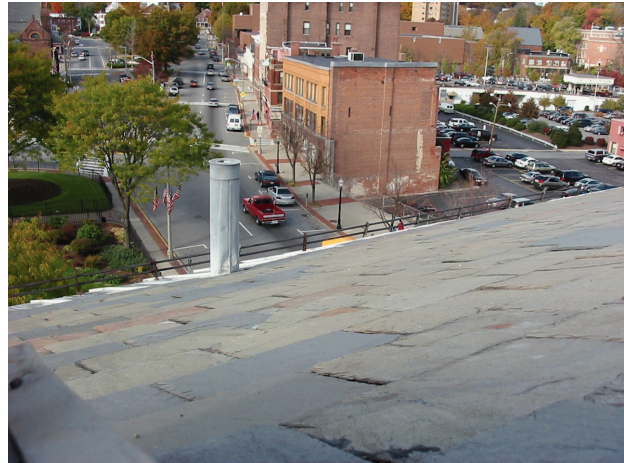
Figure 11: Mixture of different slate tiles.

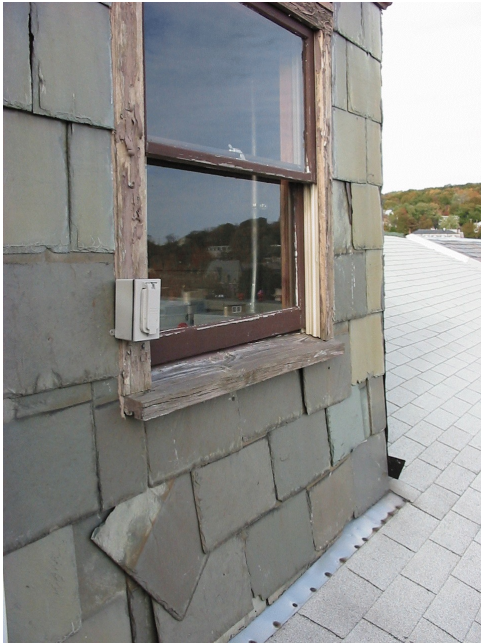
Figure 12: Falling slate tiles on dormer.

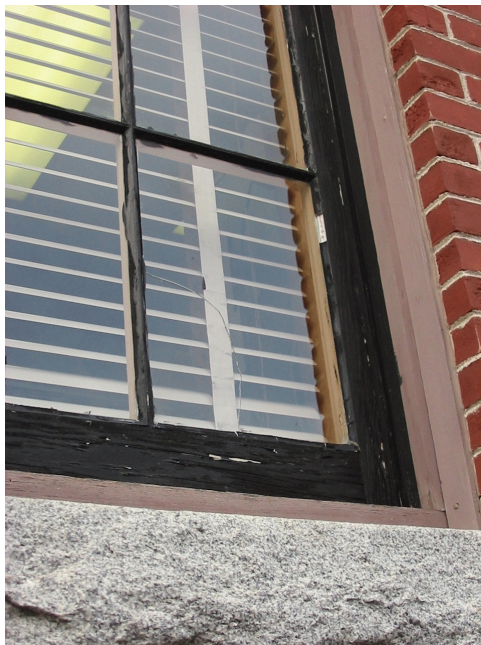
Figure 13: Single pane wood windows.

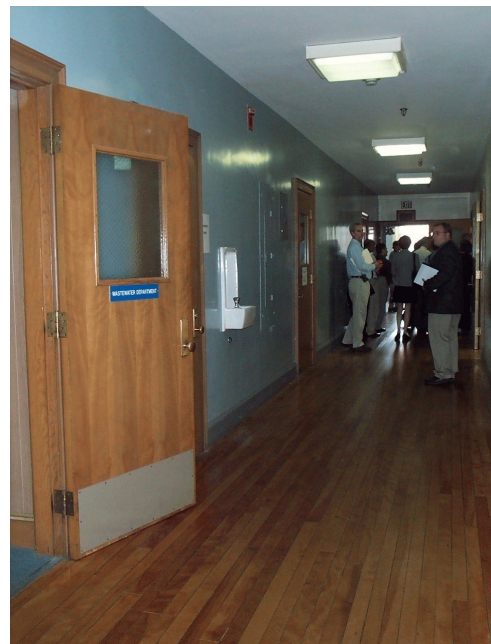
Figure 14: Out-swinging doors.

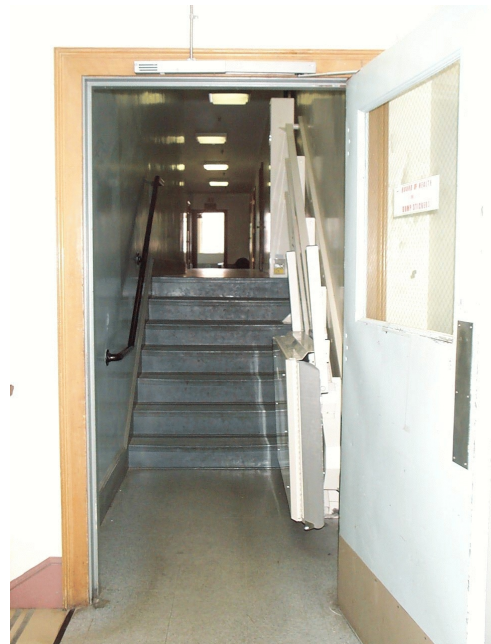
Figure 15: Stair lift in hallway.

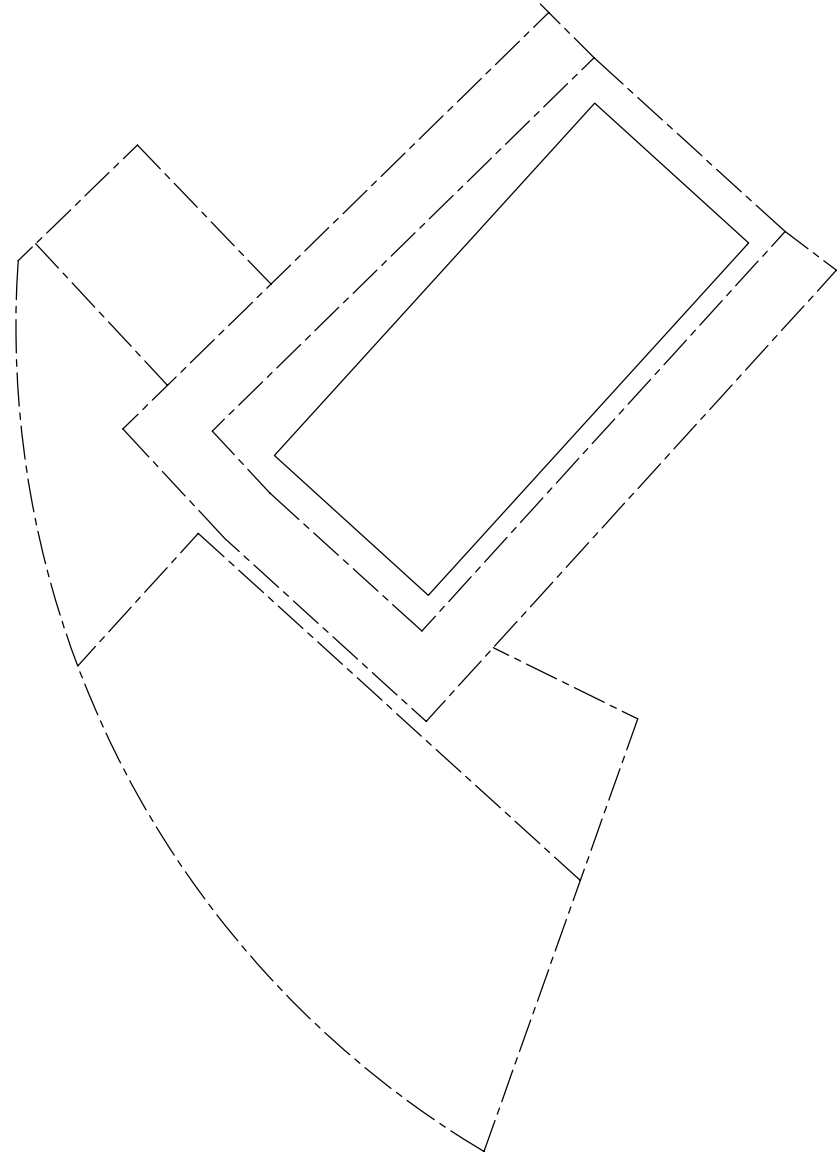
Figure 18: Existing basement floor plan

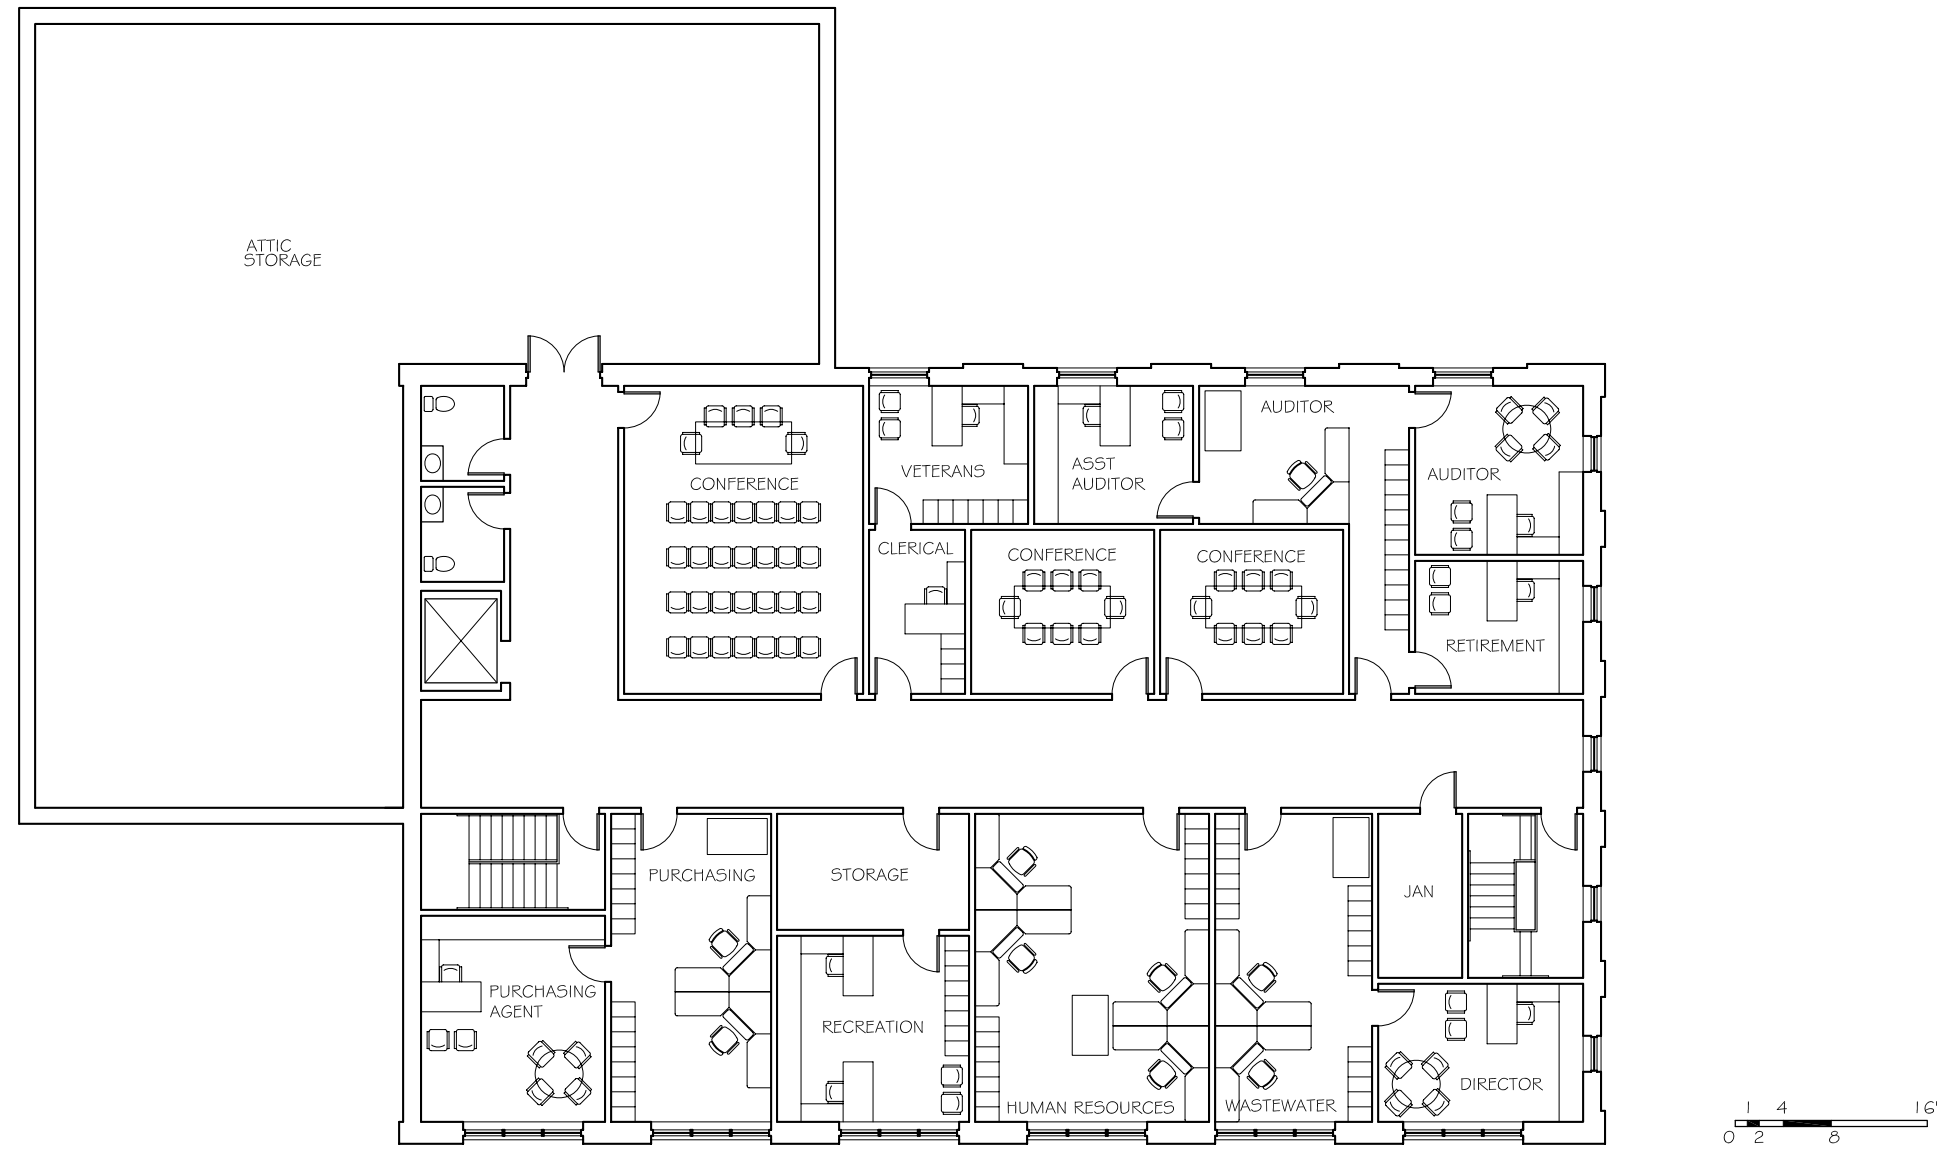
Figure 32: Scheme B third floor plan

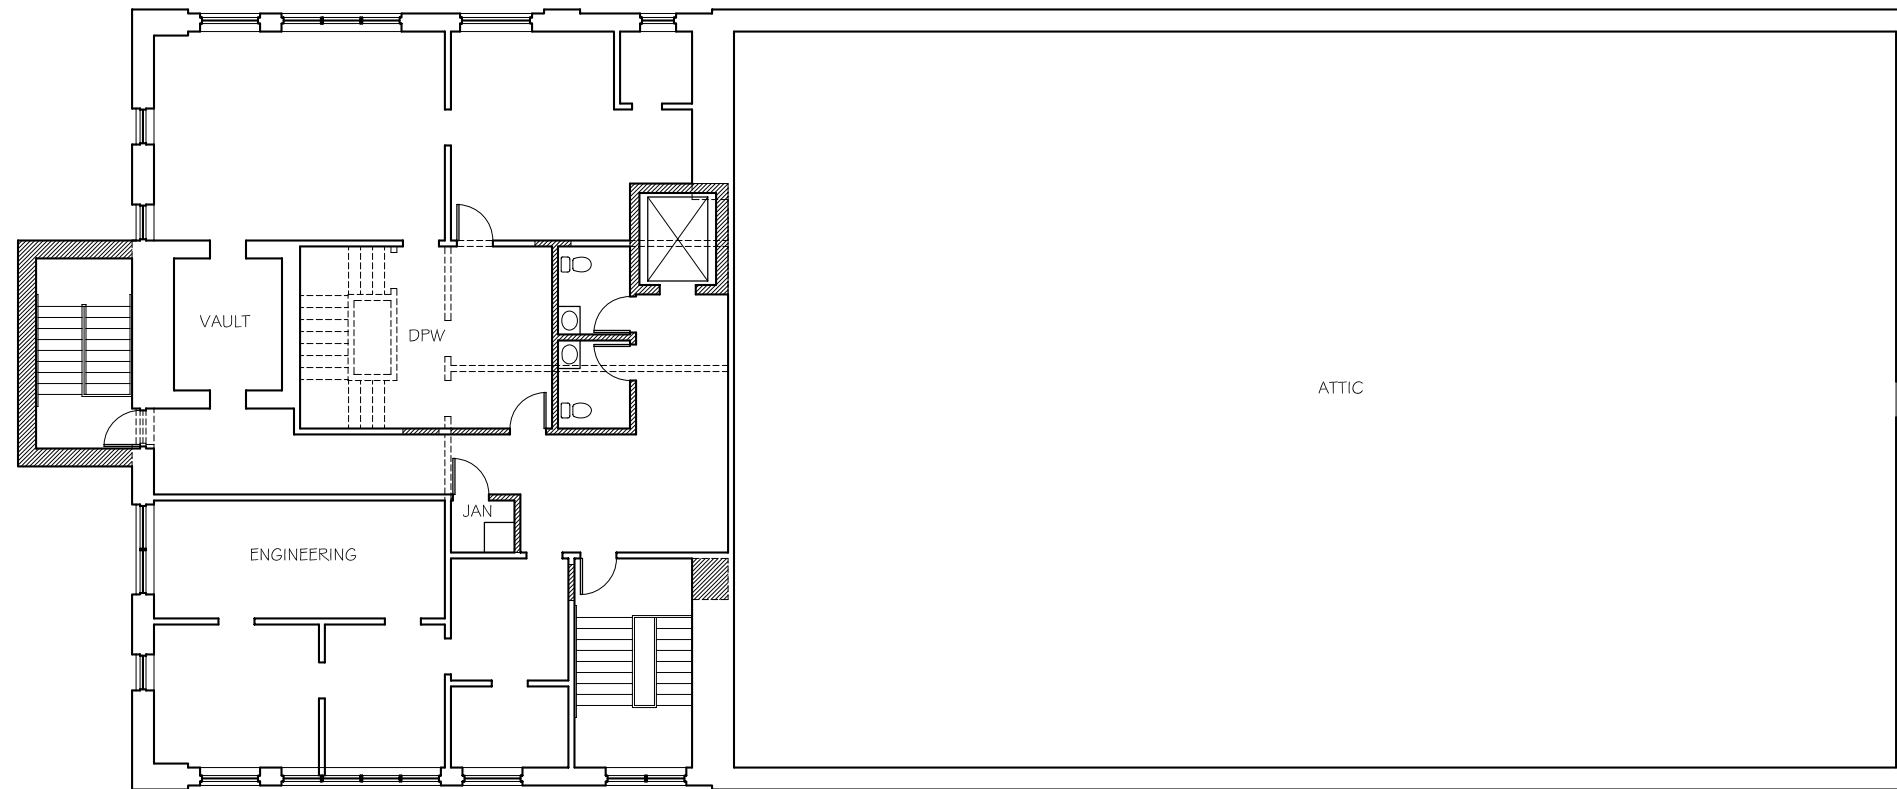
Figure 45: Scheme E fourth floor plan

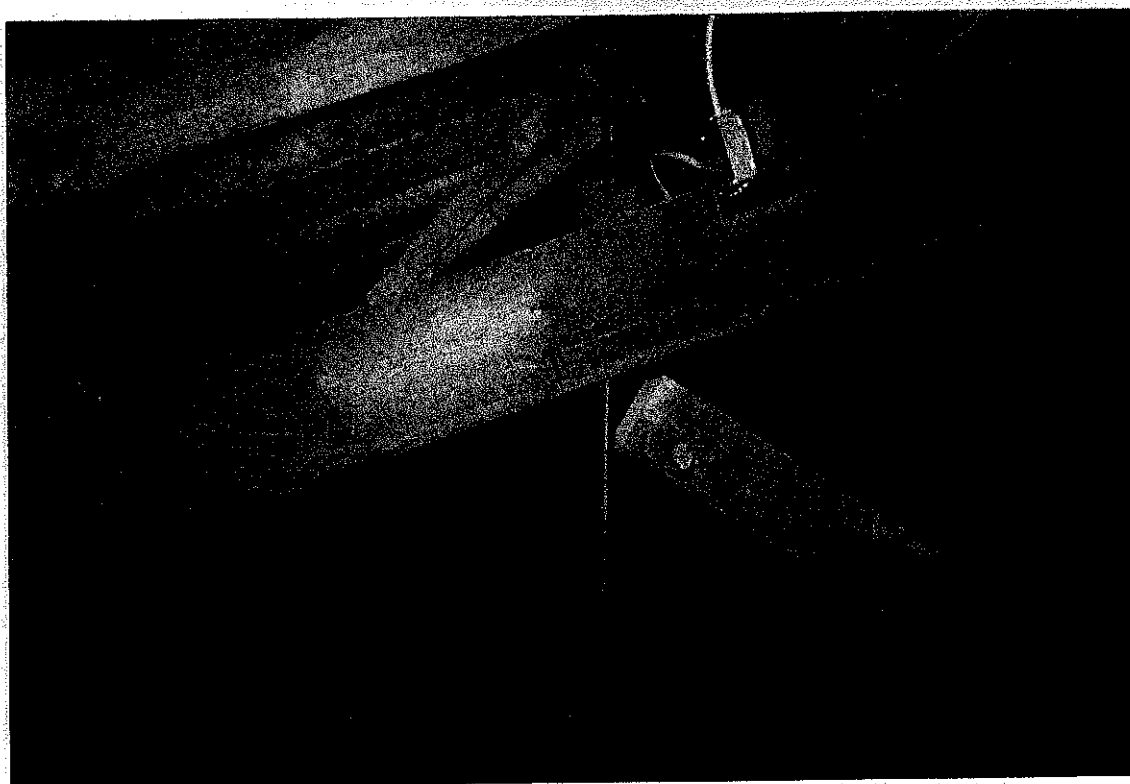
PHOTOGRAPH #6 - LOOSE DIAGONAL AND DEFLECTED TOP CHORD OF TRUSS T-1A, EAST END
