Fitchburg City Hall

718 Main Street, Fitchburg, Massachusetts

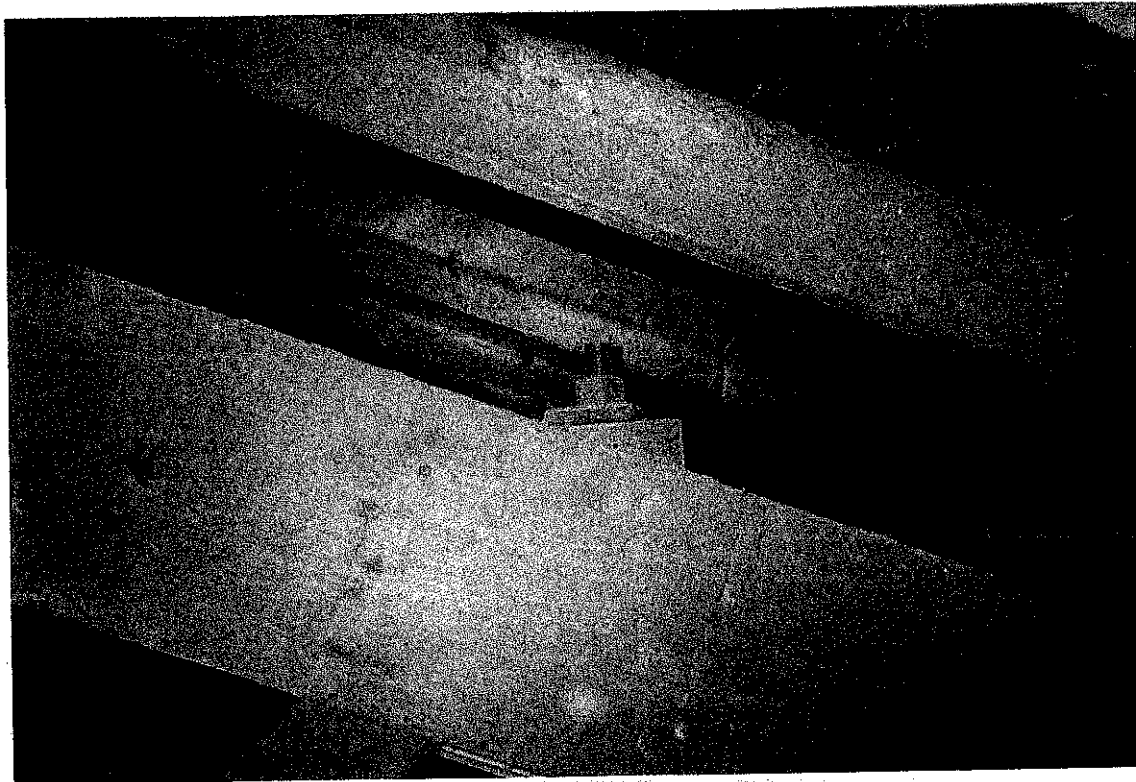
PHOTOGRAPH #7 - TYPICAL CONDITION AT TOP OF VERTICAL ROD

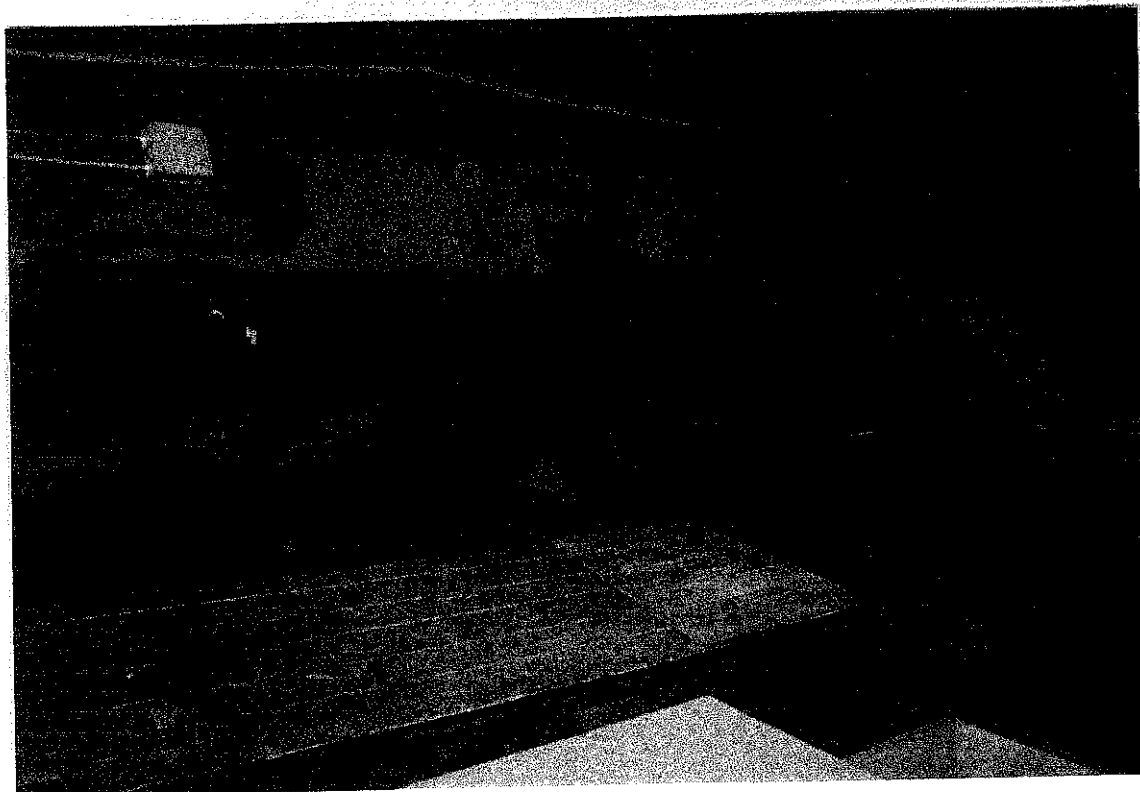
PHOTOGRAPH #8 - TYPICAL CONDITION AT END OF TRUSS

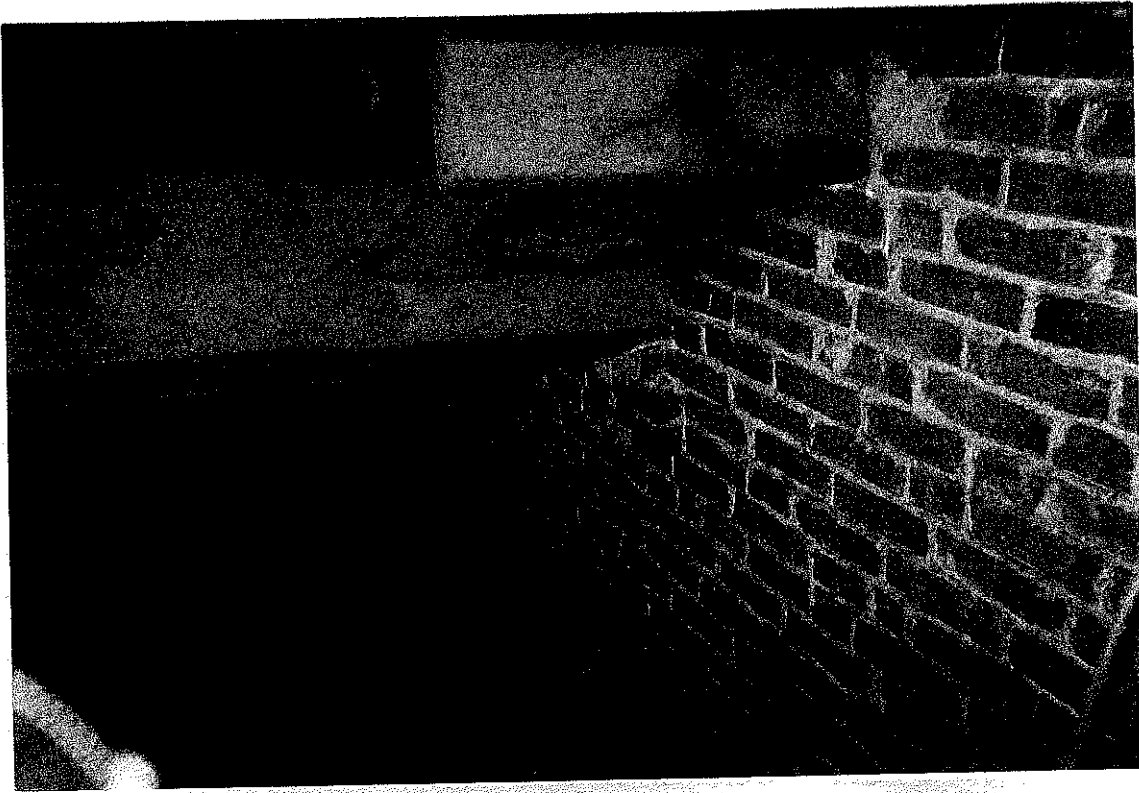
PHOTOGRAPH #9 - TYPICAL PURLIN CONDITION AT EXTERIOR WALL

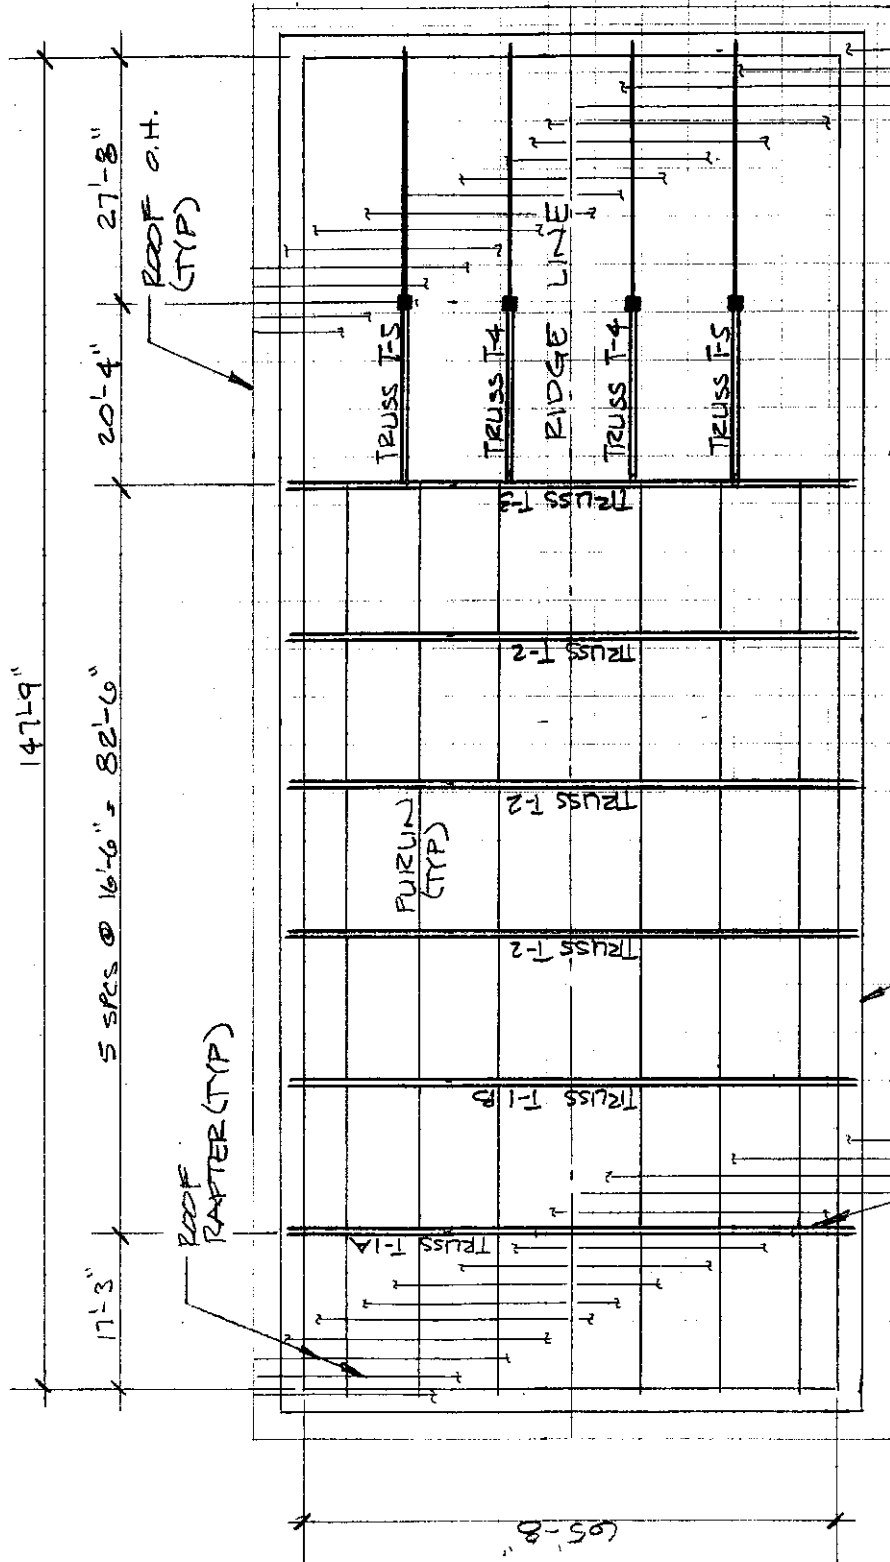
BRICK MASONRY BEARING WALL (TYP)

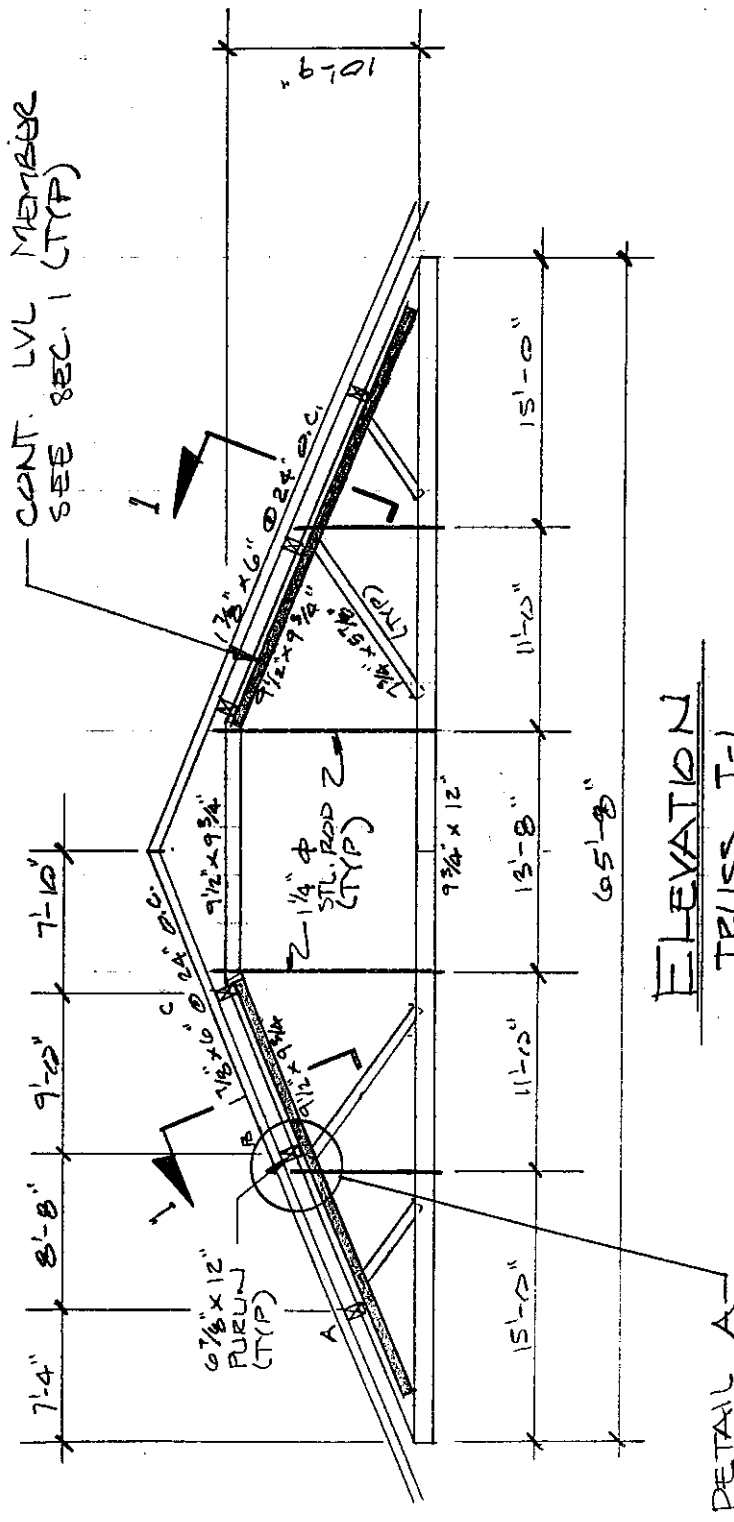
ELEVATION
TRUSS T-1
3/32" = 1'-0"

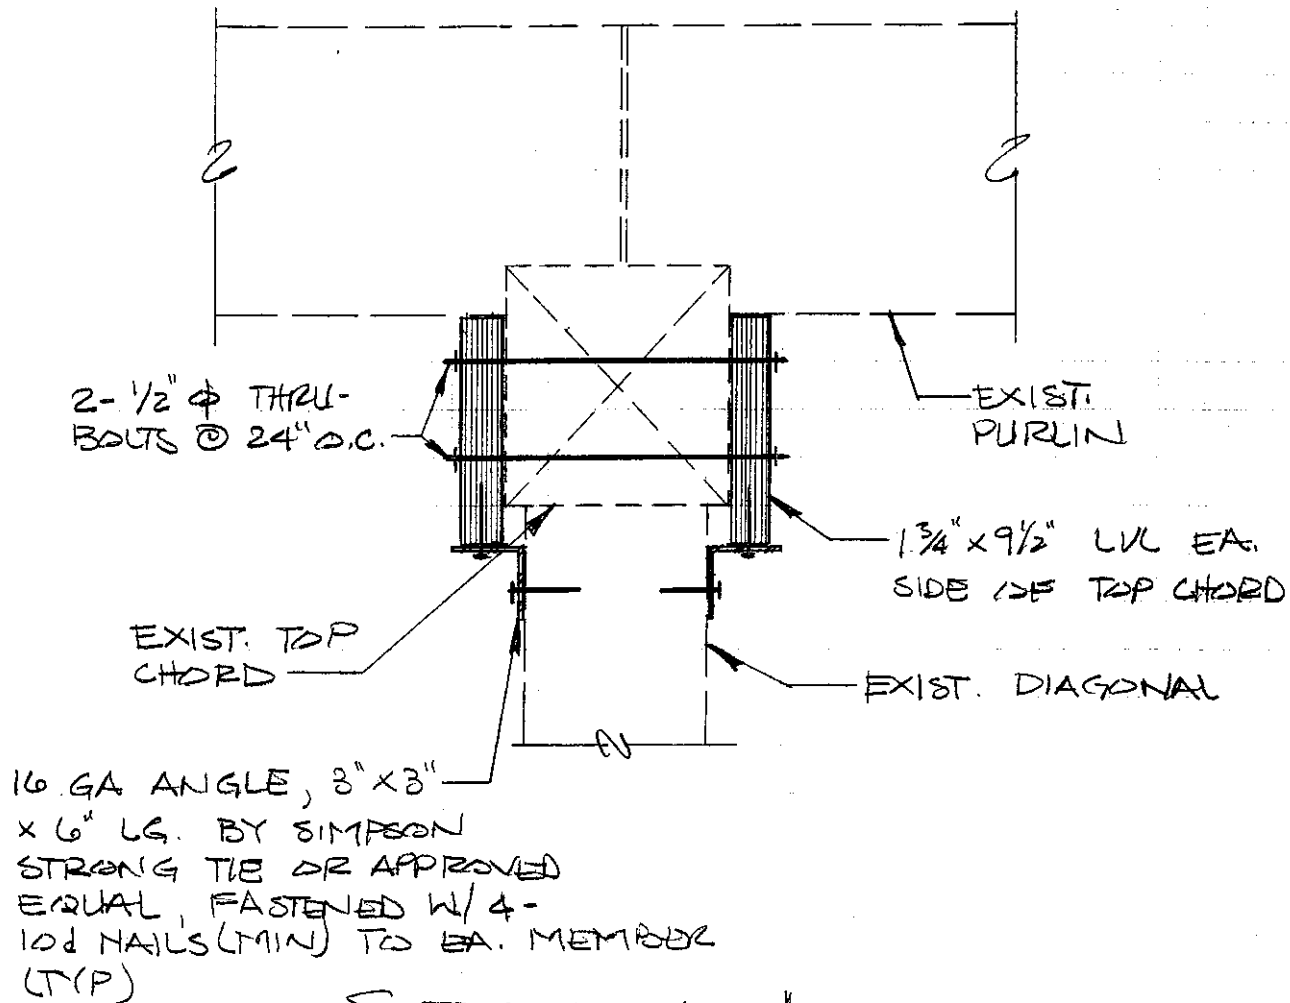
SECTION 1
TOP CHORD STIFFENING
1/2" = 1'-0"

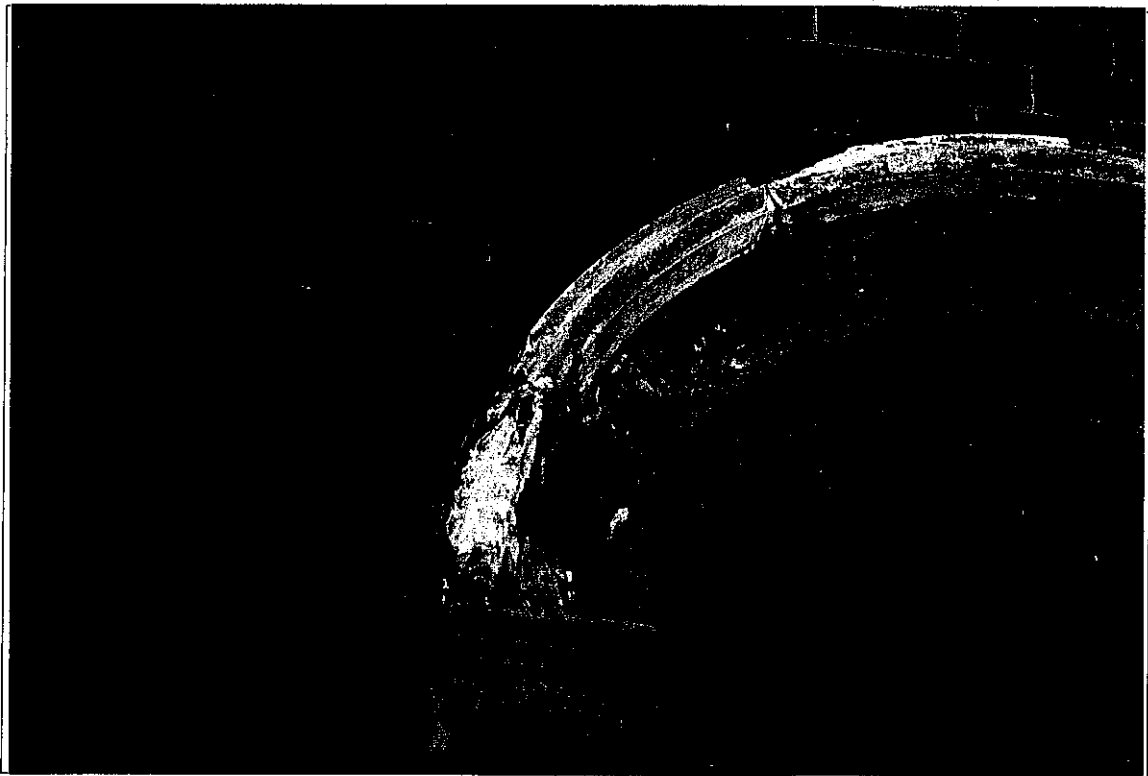
DETERIORATION OF LIMESTONE FRAME

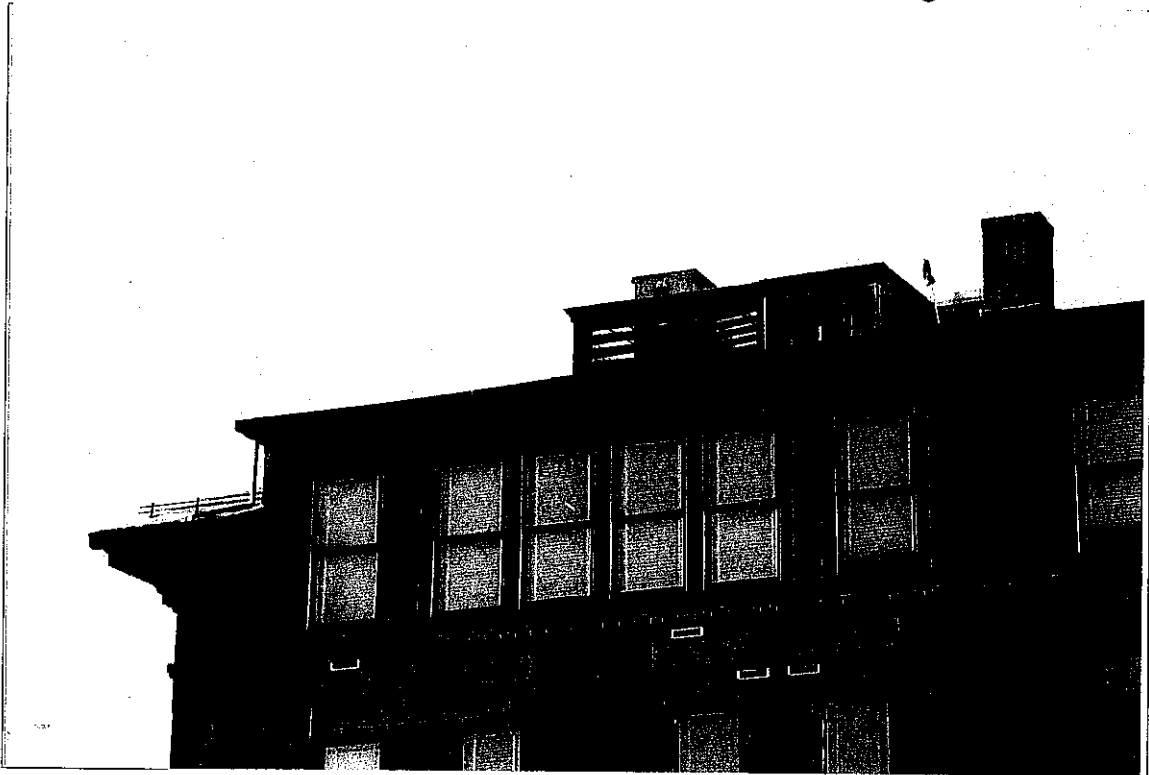
VERTICAL SLATE AT DORMER

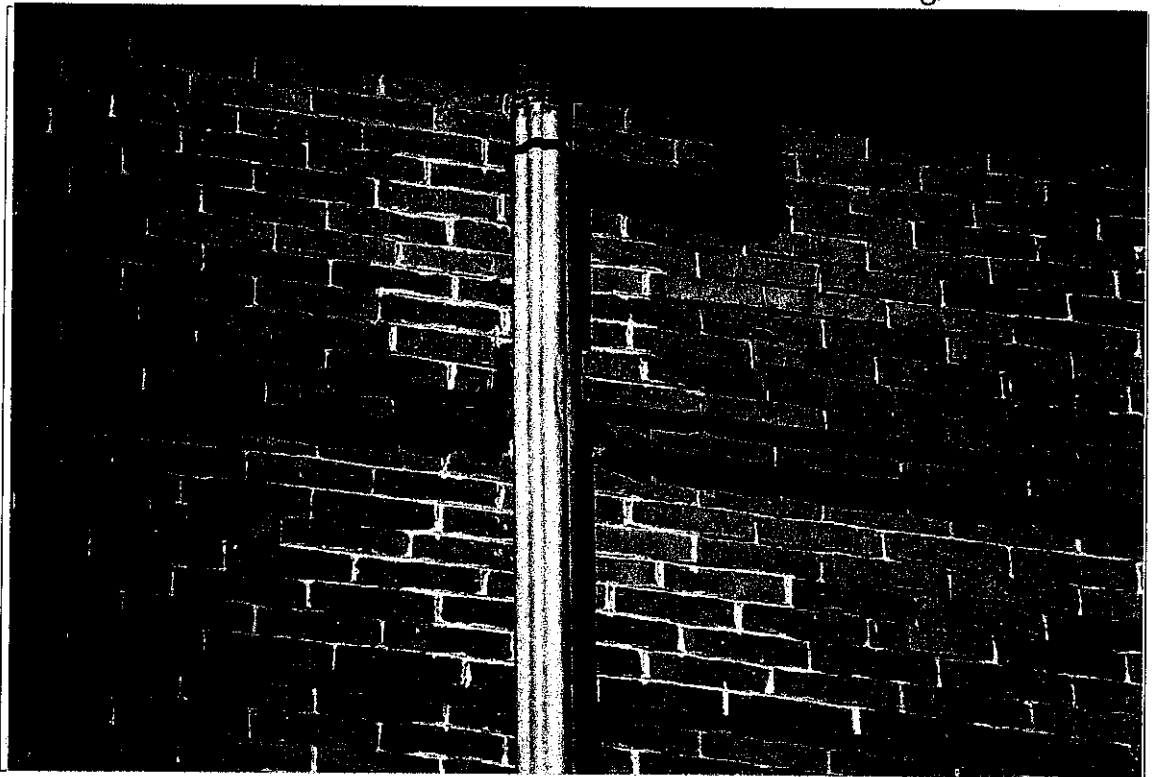
BROKEN BRICK AT CORBEL DETAIL

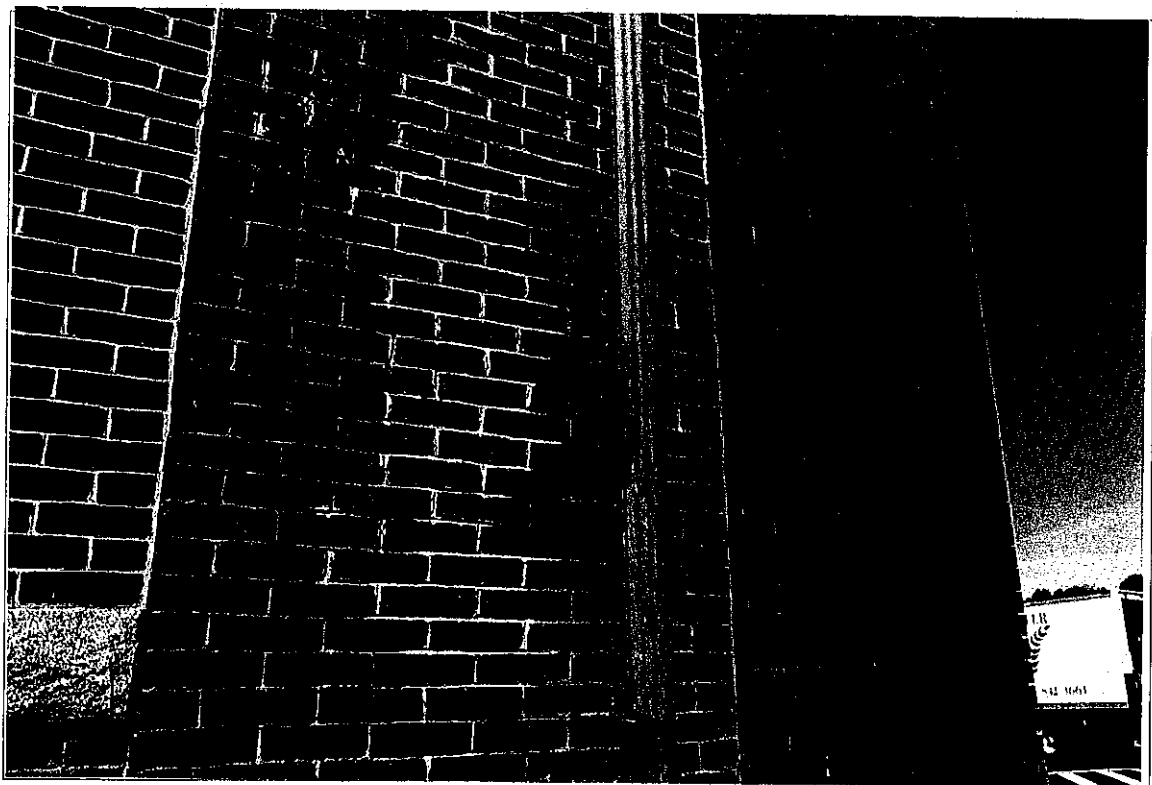
VARIOUS BRICK TYPES AND MORTAR JOINTS

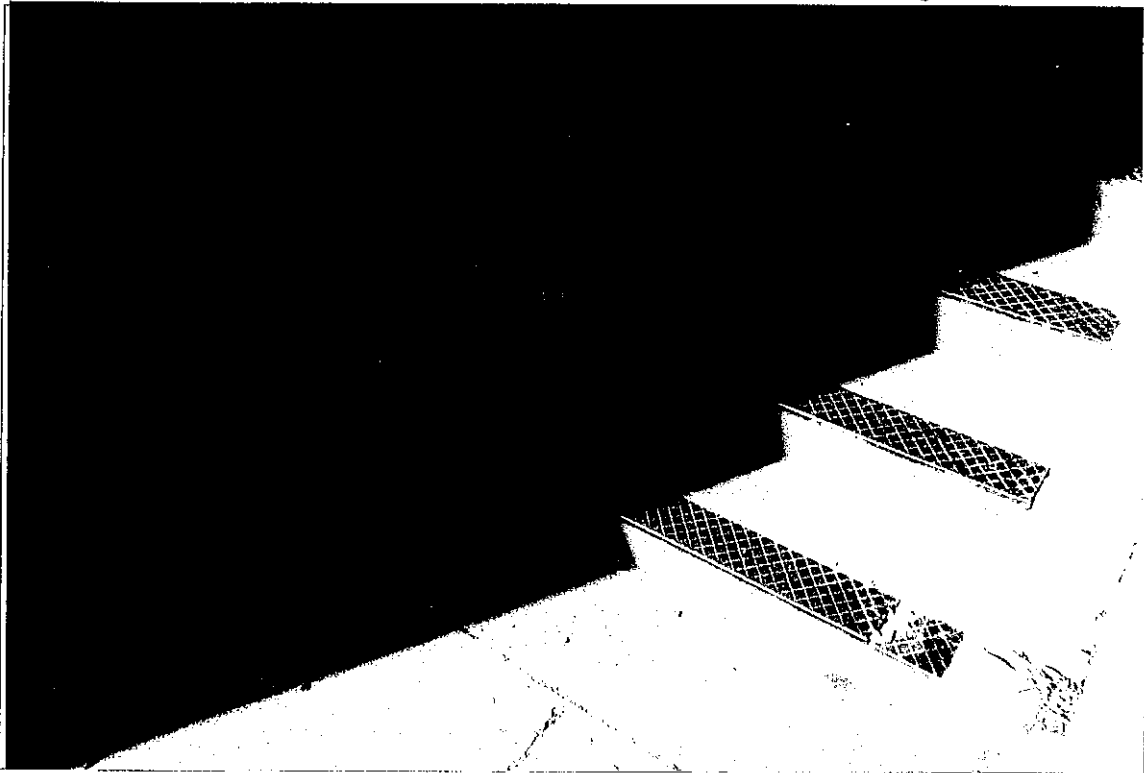
RUSTED STAIR NOSINGS AT FRONT ENTRANCE

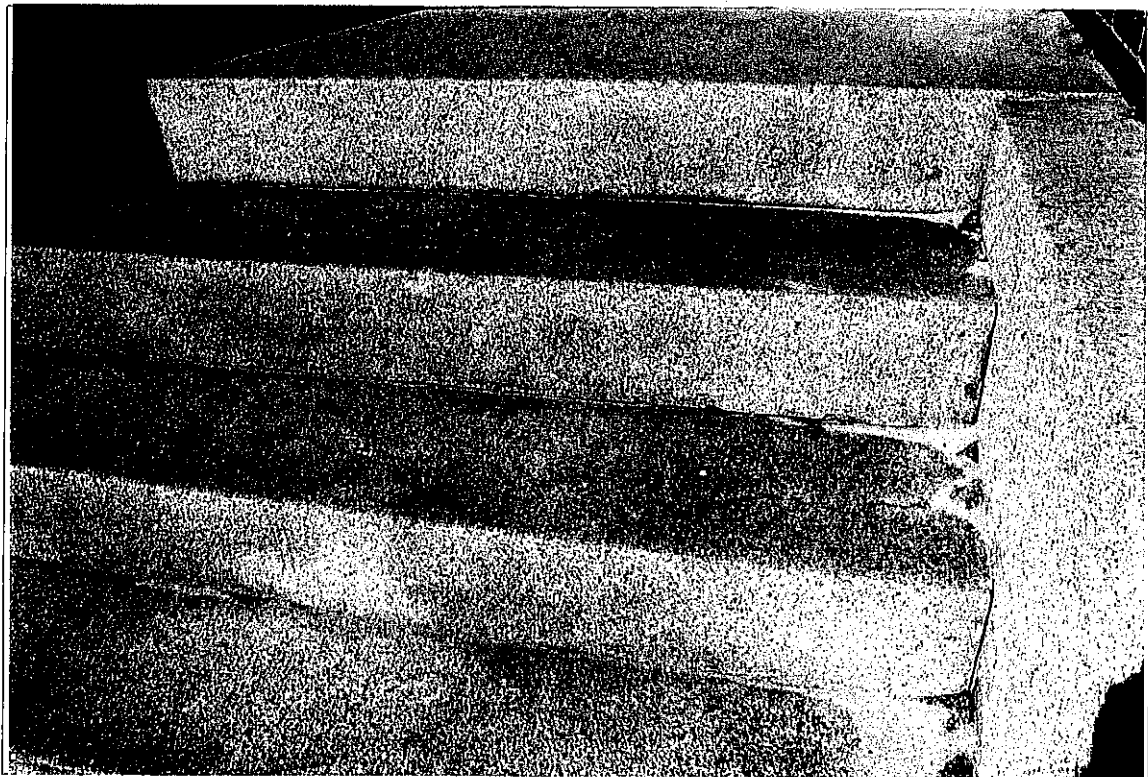
OPEN SETTING JOINTS AT SIDE STAIR

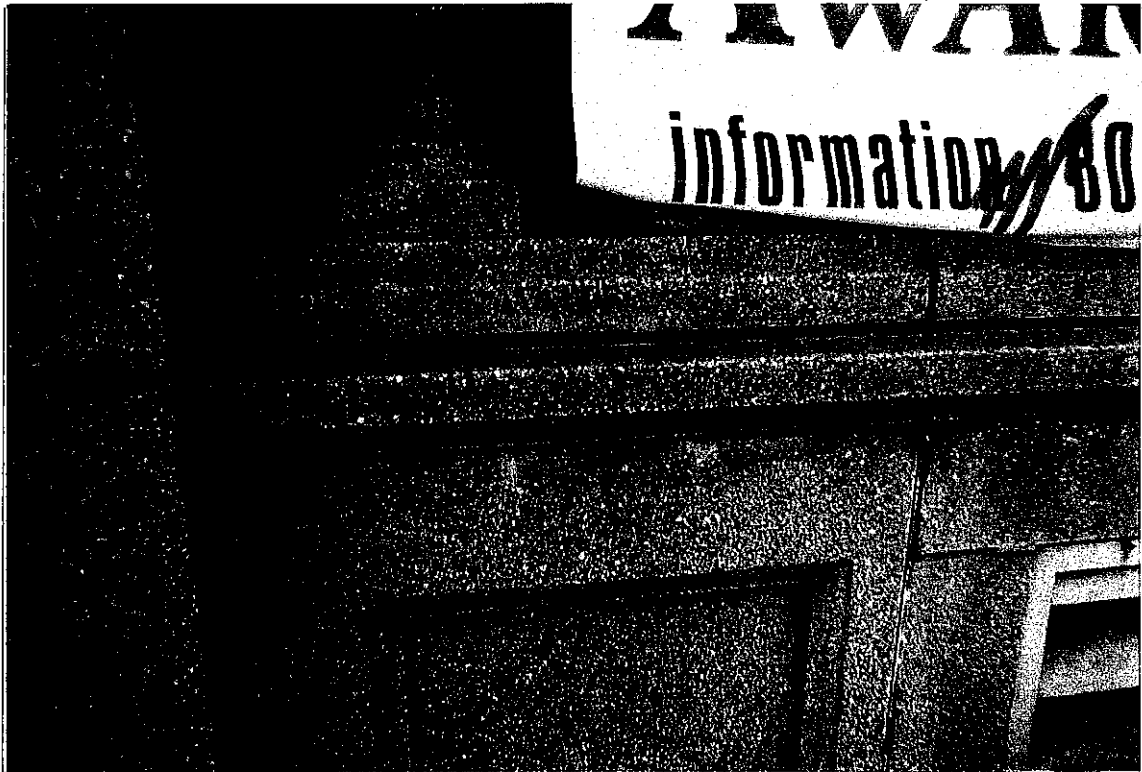
OPEN JOINTS AT GRANITE BALLUSTERS

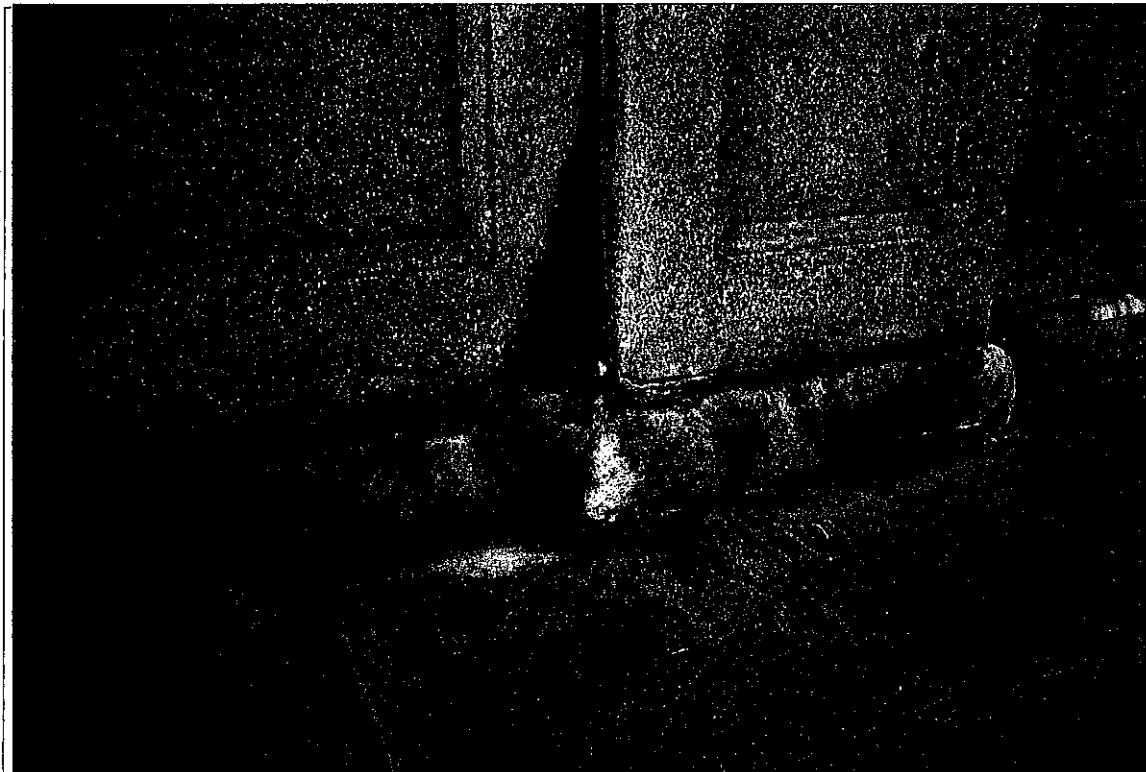
EFFLORESCENCE AND WATER STAINS AT
GRANITE BASE
