City of Fitchburg, Massachusetts

ILLICIT DISCHARGE DETECTION & ELIMINATION (IDDE) PLAN

June 2019

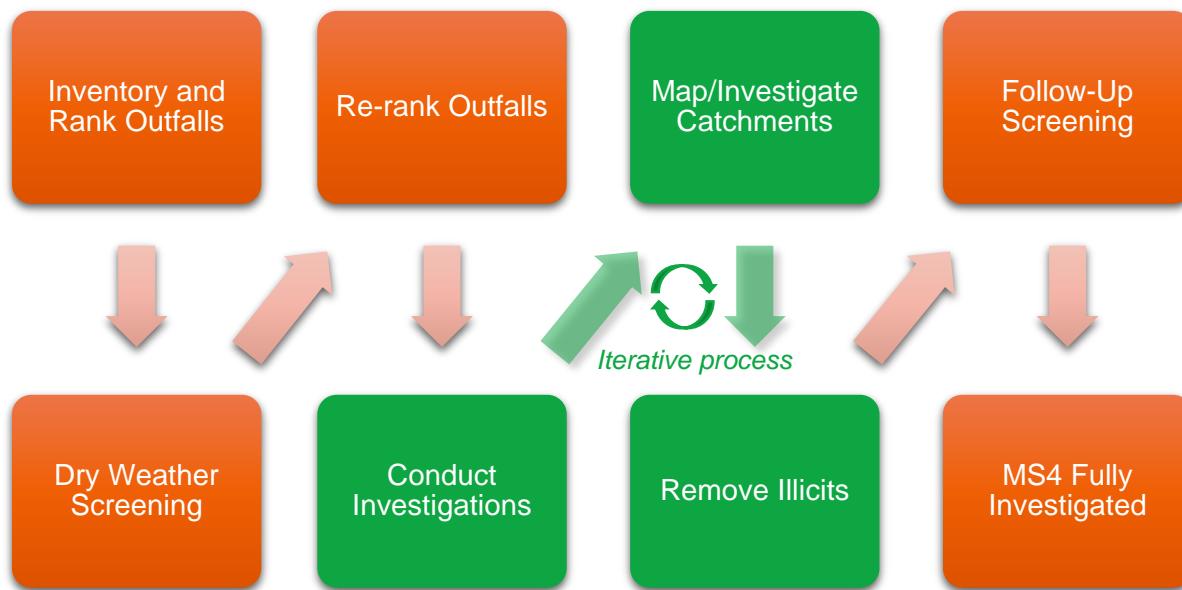
Figure 1. IDDE Investigation Procedure Framework

The IDDE investigation procedure framework shown in **Figure 1**, from the Central Massachusetts Regional Stormwater Coalition (CMRSWC), will generally be used to guide IDDE investigations work in the City throughout the permit term.

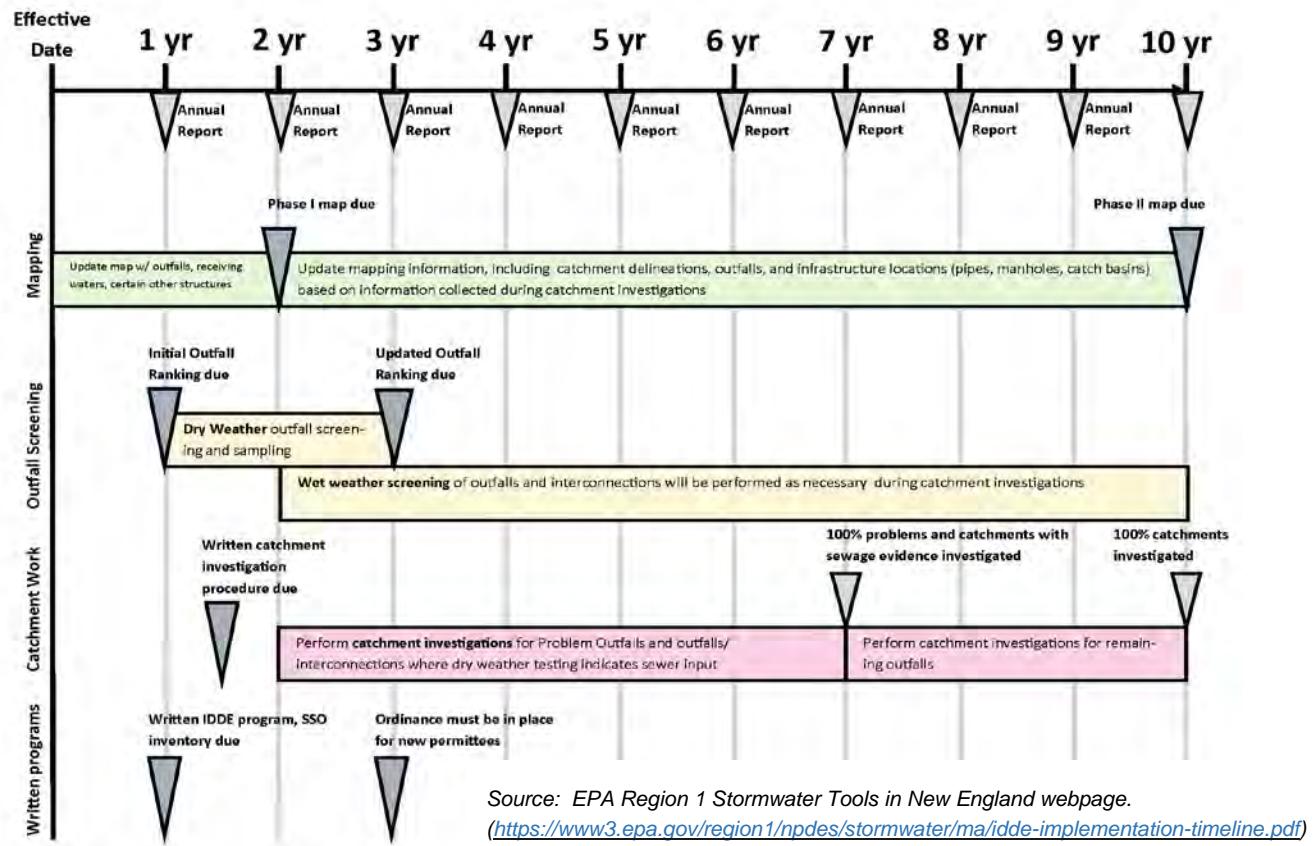
Figure 2. IDDE Program Implementation Timeline

It is the City's intent to adhere to the IDDE timeline requirements of the MS4 permit as graphically shown in **Figure 2**, as provided by the EPA. **Table 1** presents a summary of the IDDE program requirement deadlines for the current permit term.

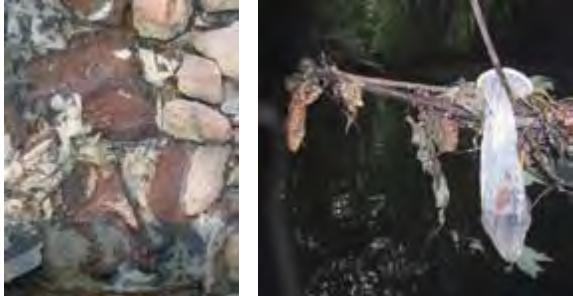
<p>Toilet paper or other sanitary items directly around the storm drain outlet are indicators of an upstream illicit connection.</p>

In the event an outfall is inspected, and no flows are observed, indicators of illicit flow evidence may be used in the determination of likely illicit discharges. Some observable evidence of an illicit discharge includes the presence of toilet paper and other sanitary items, staining, grease deposits, or excessive vegetation or bacterial growth. Examples of illicit flow evidence in non-flowing outfalls are shown in **Figure 5**. These examples are excerpts from the Illicit Discharge Detection and Elimination: A Guidance Manual for Program Development and Technical Assessments by the Center for Watershed Protection and Robert Pitt, 2004.

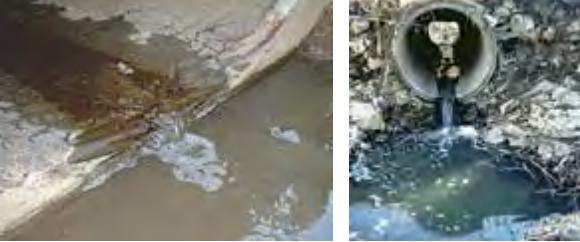
<p>Suds present at an outfall may indicate an illicit connection and likely when accompanied by the presence of a fragrant detergent odor.</p>

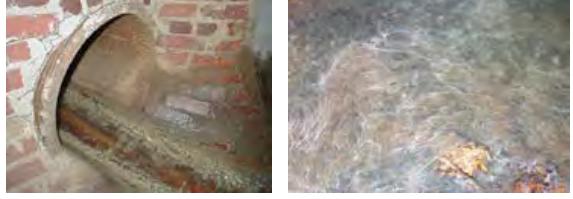
<p>Bacterial growth at an outfall indicates nutrient enrichment likely from sanitary connections / defects.</p>

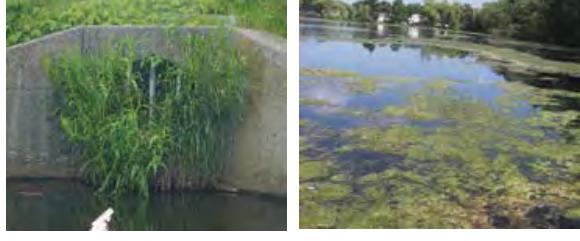
<p>Excessive vegetation and algae growth may indicate enriched flows associated with sewage or fertilizers from lawn care</p>

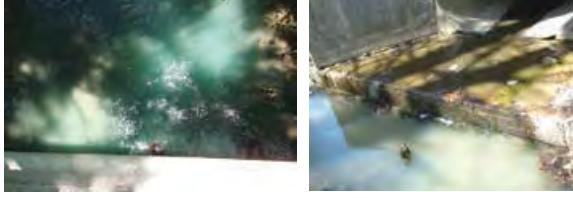
<p>Water color indicators may identify the presence of an illicit connection or illegal dumping and may require additional investigation.</p> <p>Note: water color may also be a result of minerals and algae growth</p>

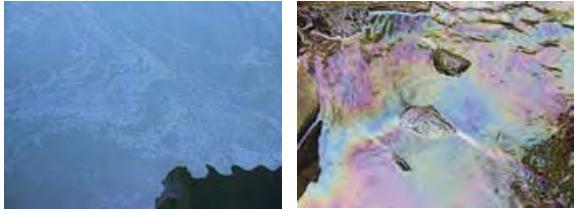
<p>Oily Sheen or Film may indicate the presence of an illicit connection or illegal dumping of pollutants.</p> <p>Note: some oils are organic and should be differentiated from Synthetic oils before using as an indicator</p>
