# **NORTH NASHUA RIVER CHANNEL REHABILITATION STUDY**

## **FITCHBURG LOCAL PROTECTION PROJECT FITCHBURG, MASSACHUSETTS**

**June 2003**

**US Army Corps  
of Engineers**

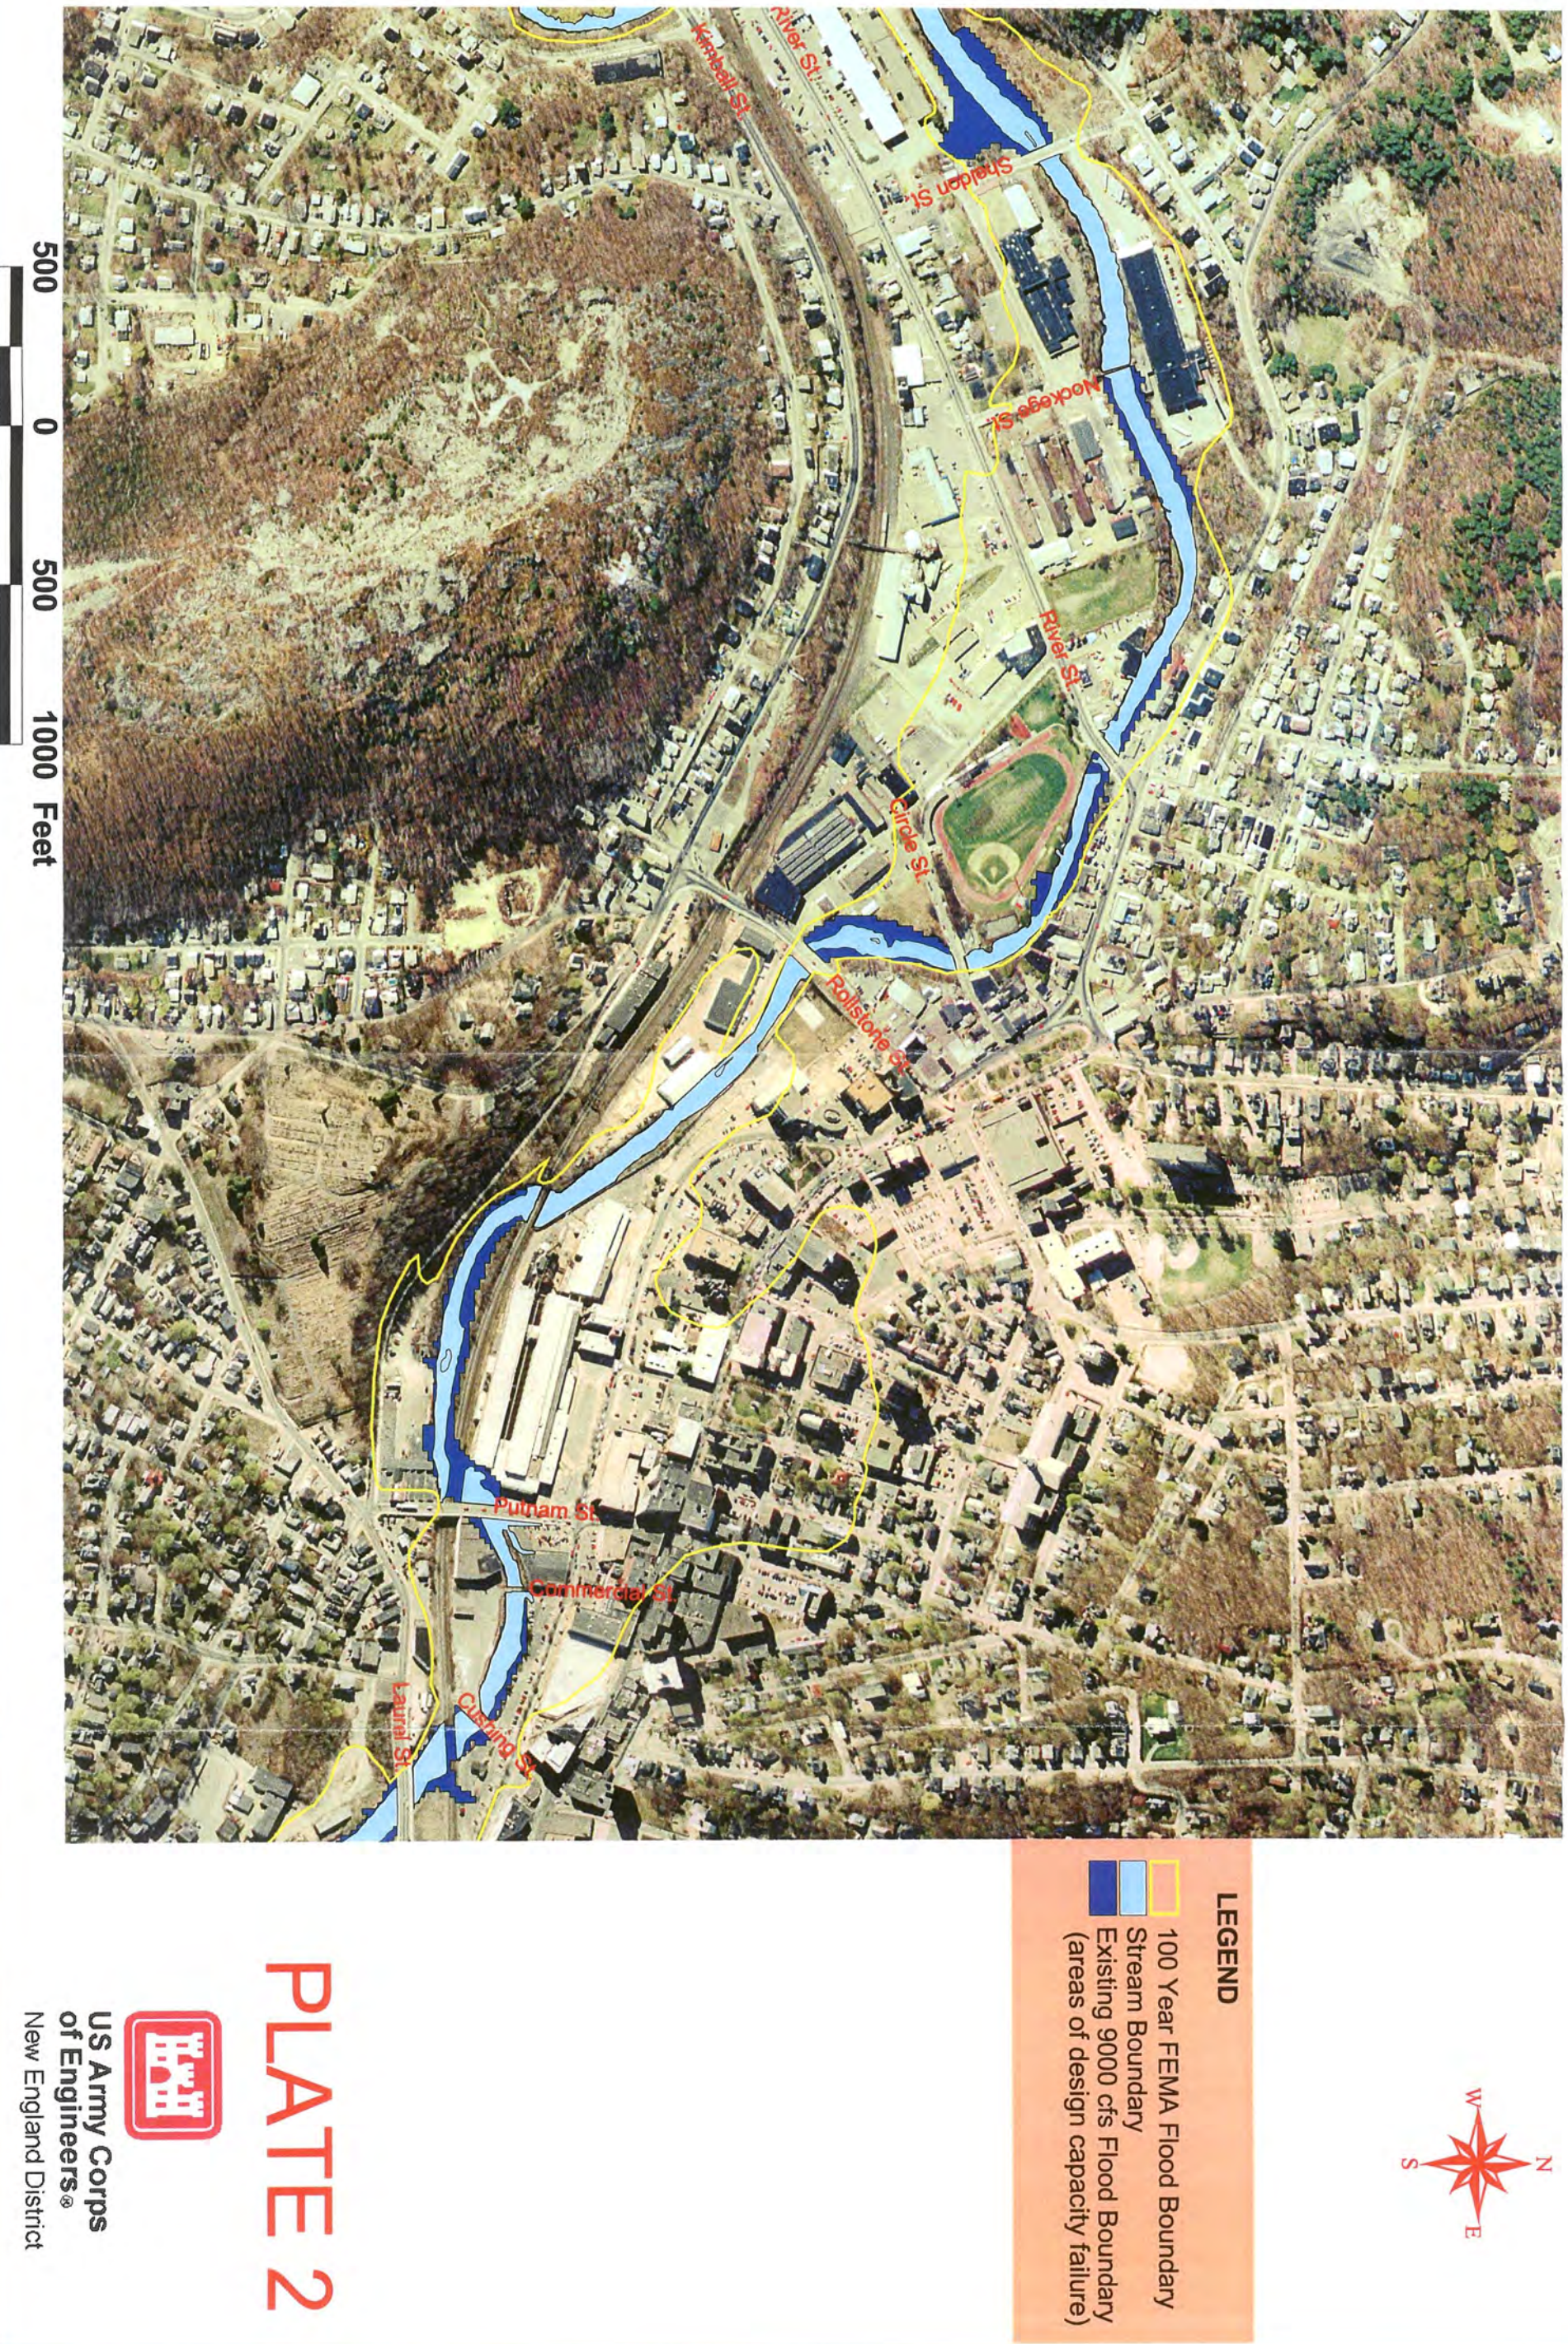
PLATE 2

North Nashua River (Fitchburg) Existing 9000 cfs Flood Boundary

(5) **From the Commercial Street bridge, to a point 100-feet upstream of the Railroad bridge upstream of Putnam Street, *first priority*:** Under existing conditions, the railroad bridge would be over-topped by the 9,000 cfs event with 0.3-feet of floodwater. Removal of vegetation from the Commercial Street bridge to a point 100-feet upstream of the railroad bridge would allow the flood stage to drop 0.7-feet, and thus the flow would pass beneath the bridge. Left in the current condition, the LPP only passes 8,500 cfs under the railroad bridge. It is recommended for this reach that channel vegetation below 443-feet NGVD be removed downstream of Putnam Street, as well as that which is below 446-feet NGVD upstream of the same bridge. Please refer to Photos 7 and 8, Profile 2 and Plate 2 in regards to the vicinity of this reach.

(6) **From railroad bridge downstream of Rollstone/Broad Street bridges, to a point 200-feet downstream of the Rollstone/Broad Street bridges, *third priority*:** Towards the middle of this reach, existing conditions provide only 1.0-feet of freeboard for the floodwall protecting the overbank area. Removal of the channel vegetation in this reach that is below 455-feet NGVD is recommended, in order to recover 1.2-feet of the freeboard that has been lost, for a total of 2.2-feet. Please refer to Photo 9, Profile 2 and 3, and Plate 2 in regards to the vicinity of this reach.

(7) **From the Circle Street bridge, to the lower River Street bridge, *second priority*:** Due to vegetation and shoaling, the floodwall between these two bridges has lost much of the previously existing freeboard. At one point (180-feet upstream of the Circle Street bridge), only 0.3-feet of the previously existing 1.9-feet of freeboard is still available. The shoaling that has developed upstream of the Circle Street bridge is mostly responsible for this, but the vegetation's influence is considerable as well. Removal of the shoaling would restore 1.0-feet of freeboard, while removal of the vegetation would gain the remaining 0.6-feet. Vegetation removal would be of higher priority in the lower half of this reach, but total removal of vegetation between the two bridges would restore valuable freeboard throughout. It is recommended that channel vegetation below 462-feet NGVD and shoaling be removed from this reach. Please refer to Photo 11, Profile 3 and Plate 2 in regards to the vicinity of this reach.

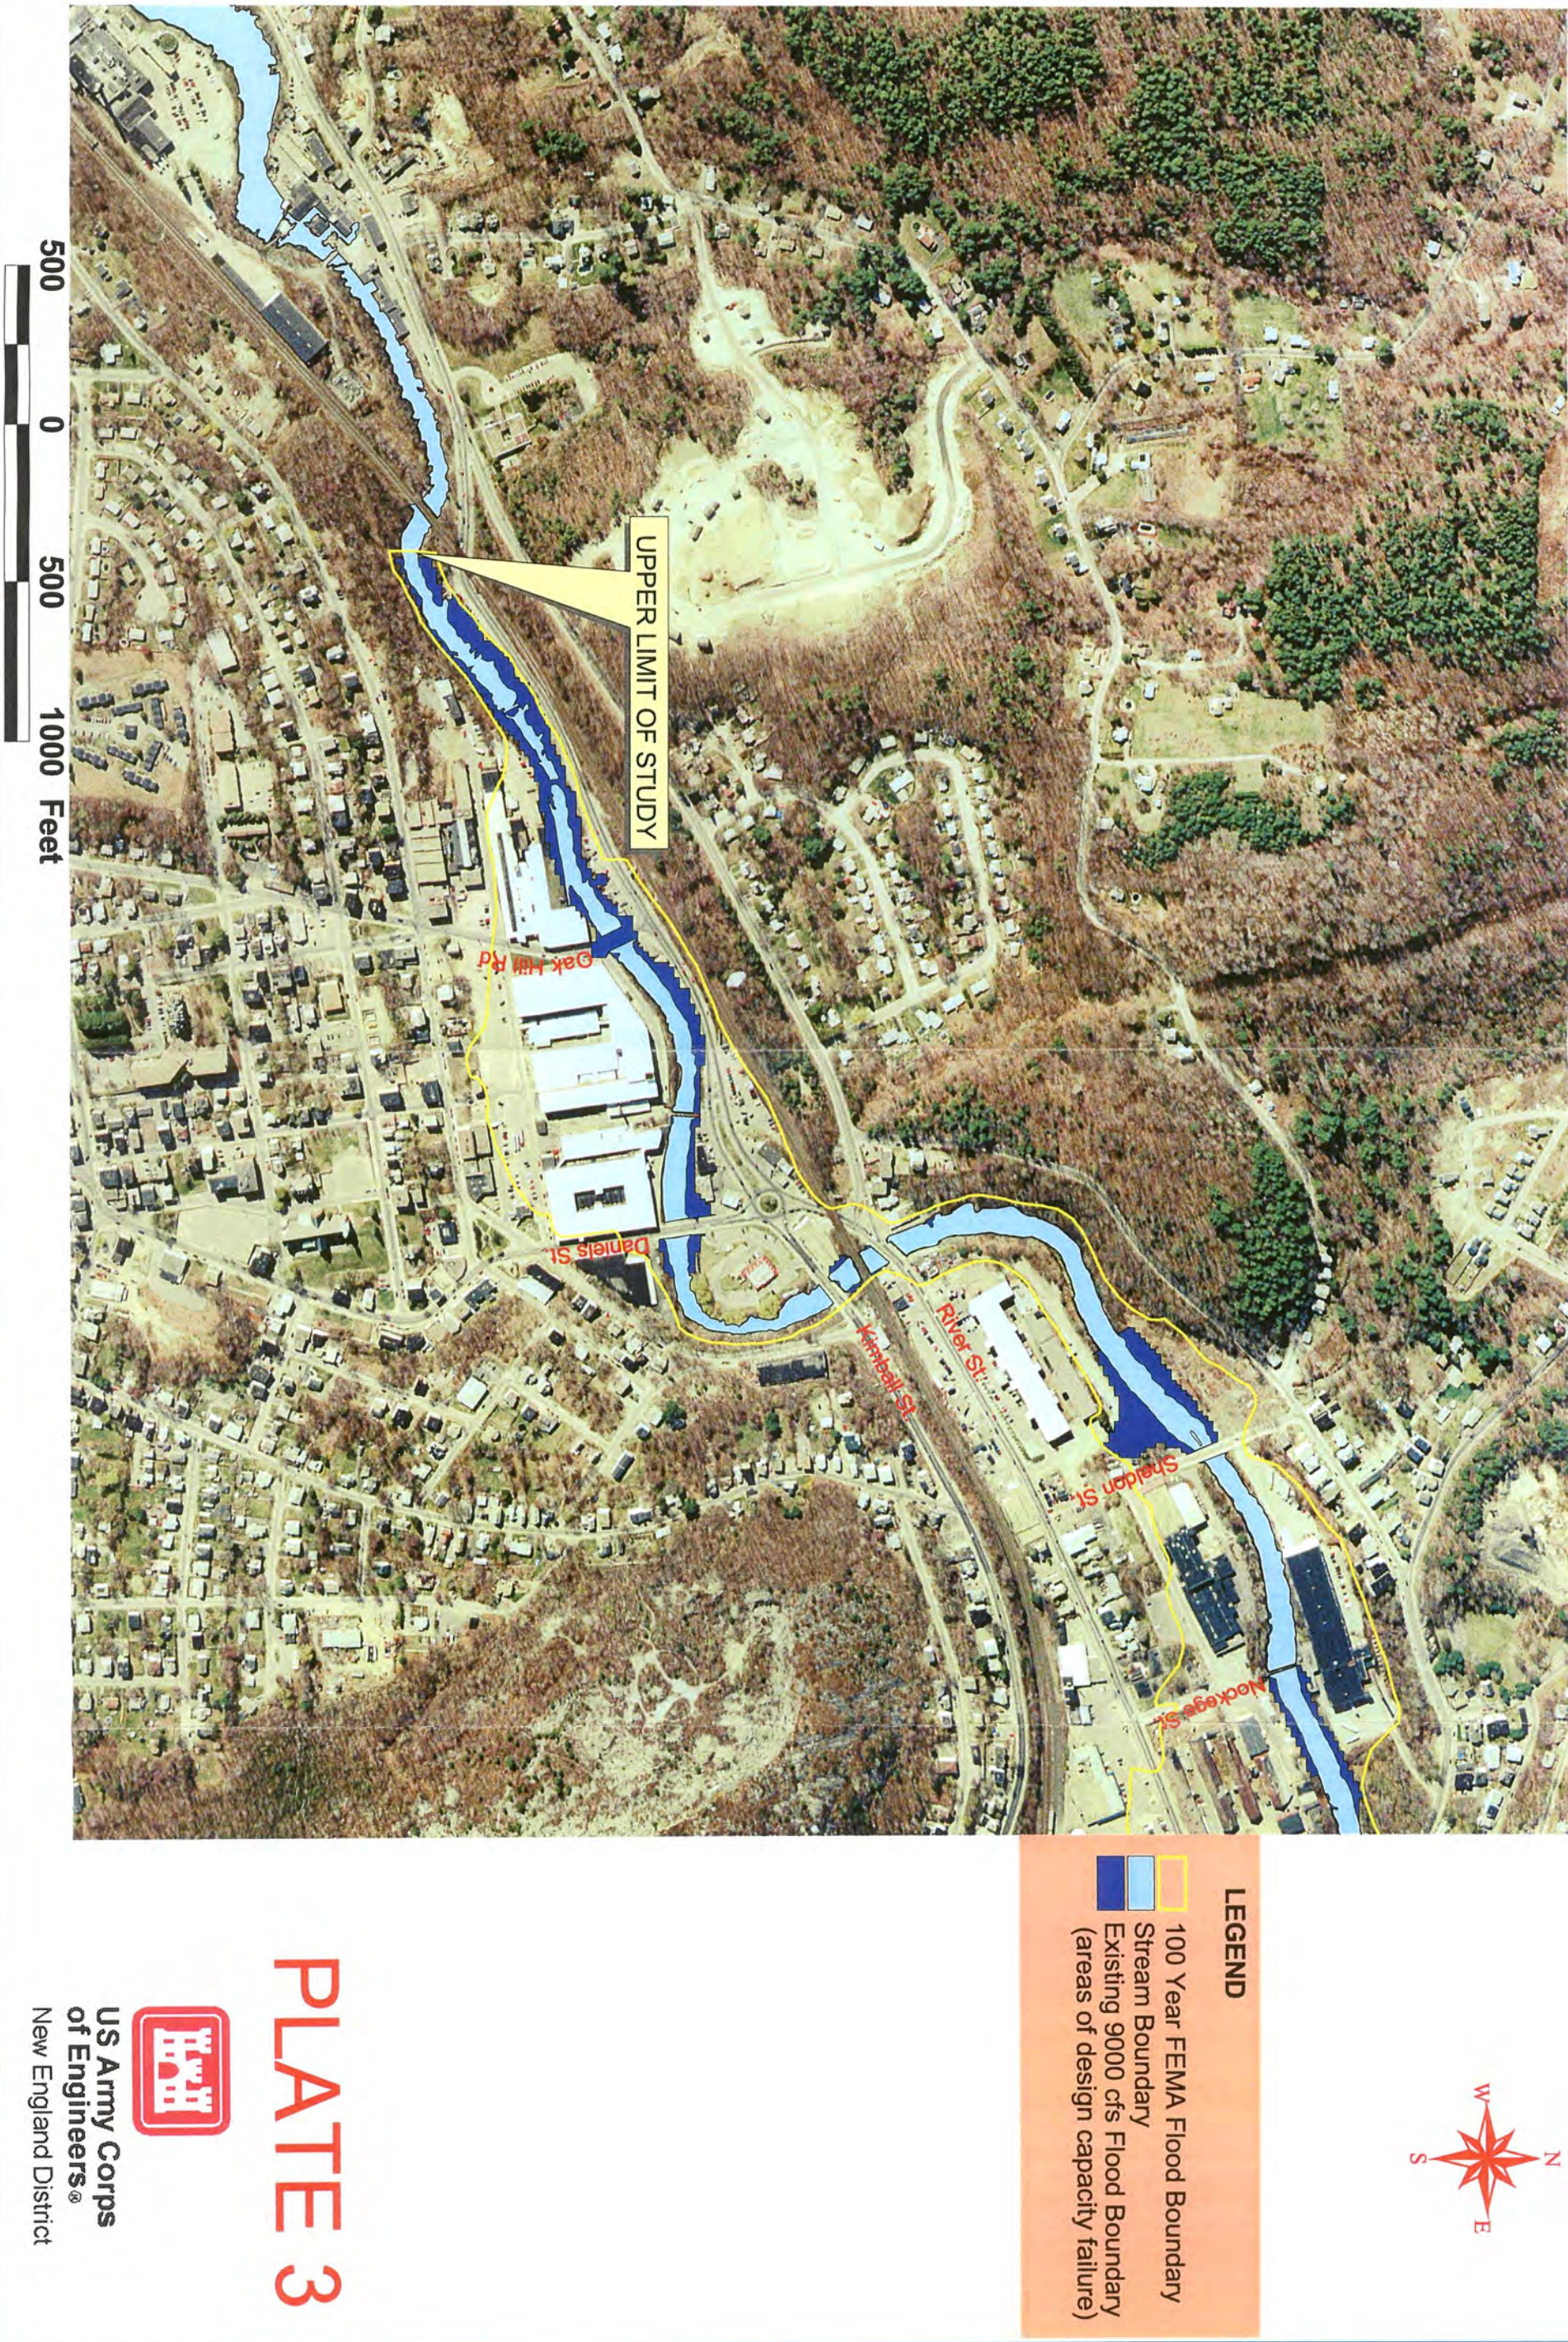
North Nashua River (Fitchburg) Existing 9000 cfs Flood Boundary

capacity. Left in the current condition, the LPP only passes 8,500 cfs under the Oak Hill Road bridge. Within this reach, it is recommended that channel vegetation below 501-feet NGVD and shoaling upstream of the Oak Hill Road bridge, as well as channel vegetation below 499-feet NGVD that is downstream of the bridge, be removed. Please refer to Photos 14 and 15, Profile 5 and Plate 3 in regards to the vicinity of this reach.

NOTE: Although flooding was determined for the reach above Sheldon Street under the design capacity condition, the area was not prioritized due to the results of the analysis. It was found that the Sheldon Street bridge is the significant controlling factor in the immediate vicinity, and that no appreciable change in flood elevation can be gained from vegetation or shoal removal. However, it is recommended that the pier upstream of the bridge (no longer in use, having formerly supported a demolished building that spanned the river) be removed, so that debris carried downstream during flood events is less likely to collect and further constrict flow under the bridge. Please refer to Photo 13, Profile 4 and Plate 3 in regards to the vicinity of this reach.
